## Preliminary Arborist Report

477 9<sup>th</sup> Avenue  
San Mateo, CA 94402

May 16, 2022

TREE DISPOSITION NOTES AND LEGENDS **L-5.2**

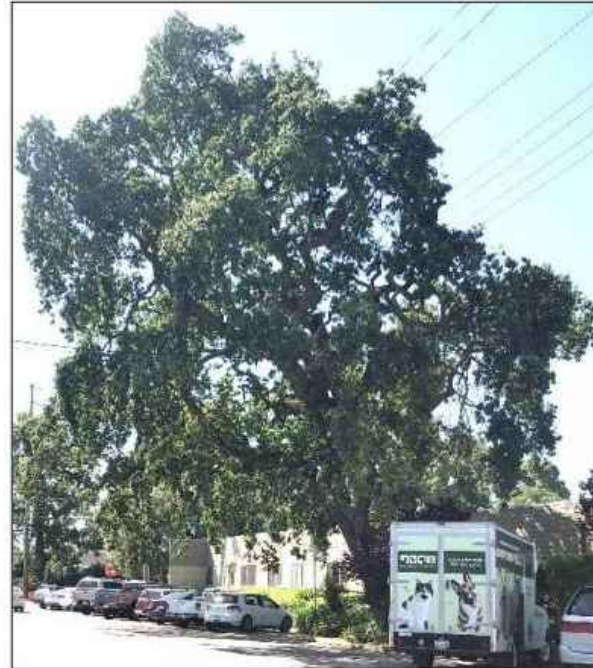
The largest tree assessed (56 inch trunk diameter) was valley oak #11 on the northeast side of the property (Photo #1). Along with purpleleaf plum #12, these were the only street trees and were growing in an approximately 8 foot by 35 foot island extending into South Claremont Street. Cavities were visible in three large limbs including a beehive within the southeast stem. The west-side canopy of the tree had been pruned for utility line clearance.

**Photo 1.** The crown of valley oak #11 had been pruned for overhead utilities but extended far over South Claremont Street.

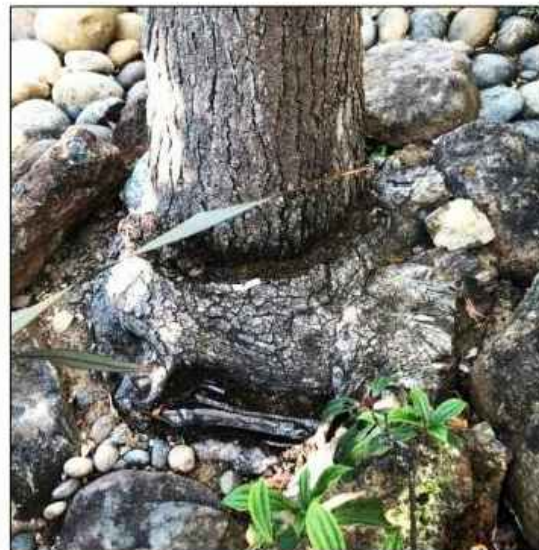
Ten sweetgums were included in the assessment. All the sweetgums were planted in the same courtyard, and 7 of the 10 sweetgums were growing in raised planters. All the sweetgums had been topped and had weakly attached branches as a result. Nine sweetgums were in fair condition and sweetgum #27 was in poor condition; the roots of this sweetgum had been pruned on three sides at 1 foot from the trunk (Photo #2).

**Photo 2.** Roots had been cut on three sides of sweetgum #27.

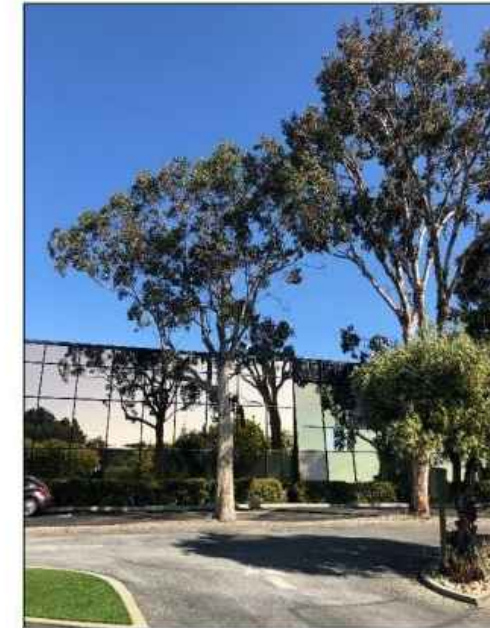
Six silver dollar gums were assessed, and all were in fair condition. All six trees were growing in a 3-foot-wide planting strip on the northwest side of the property (Photo 3). Silver dollar gums #4-6 had sparse, crowded canopies due to their proximity to one another. Silver dollar gums were some of the largest trees assessed with an average trunk diameter of 25 inches. In particular, trees #7-9 had larger diameter trunks that filled the narrow planting strip.

**Photo 3.** The silver dollar gums (#5 and 6 shown) were growing in a row in narrow planting strip.
