Structural Cost Estimate Narrative and Conceptual Retrofits

mack5 was requested to carry out a Conceptual Design Cost Plan for the proposed renovation of existing Martin Luther King Community Center, located at 725 Monte Diablo Ave., San Mateo, CA 94403.

**(E) Building Remodel & Upgrade
Martin Luther King Community Center**

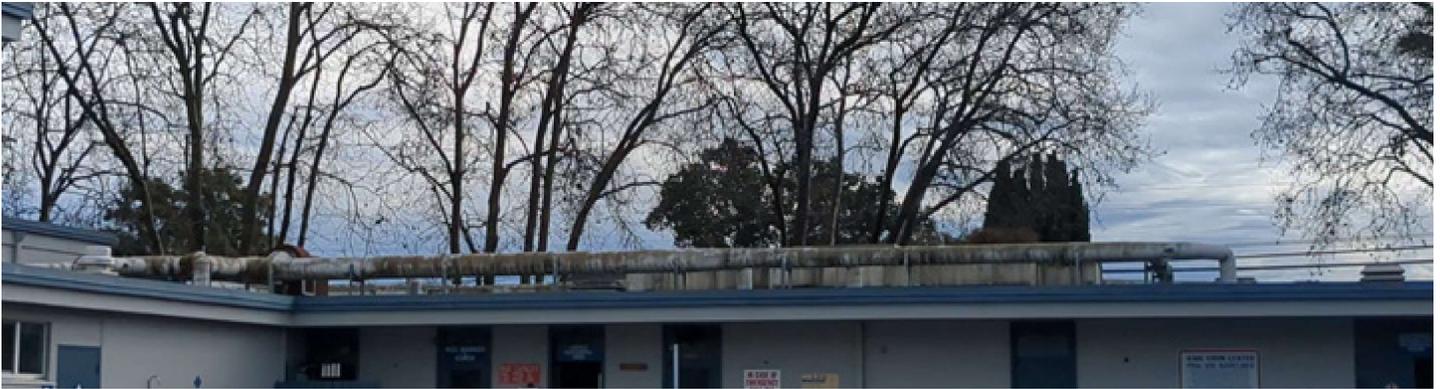
Roof mounted ductwork

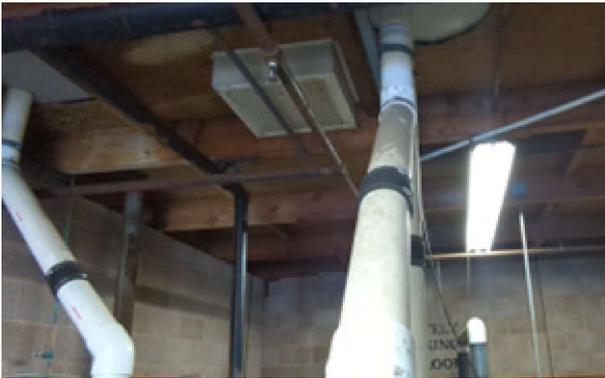
Boiler Room Exhaust

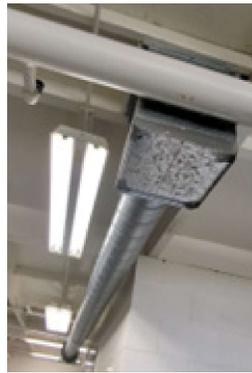
Locker Room Exhaust Ductwork

The women's locker room has exposed exhaust ductwork that has condensation dripping from the exhaust air plenum. We recommend placing all the ductwork within the building envelope and it should be insulated to prevent condensation. The men's locker room exhaust should be replaced with a similarly ducted system as the women's to help move air around the space. The exhaust system shall be designed to provide ventilation but also prevent stagnant, moist air from settling in the space.

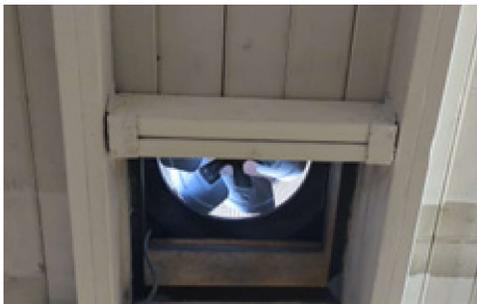
Pool Equipment Room Exhaust Fan

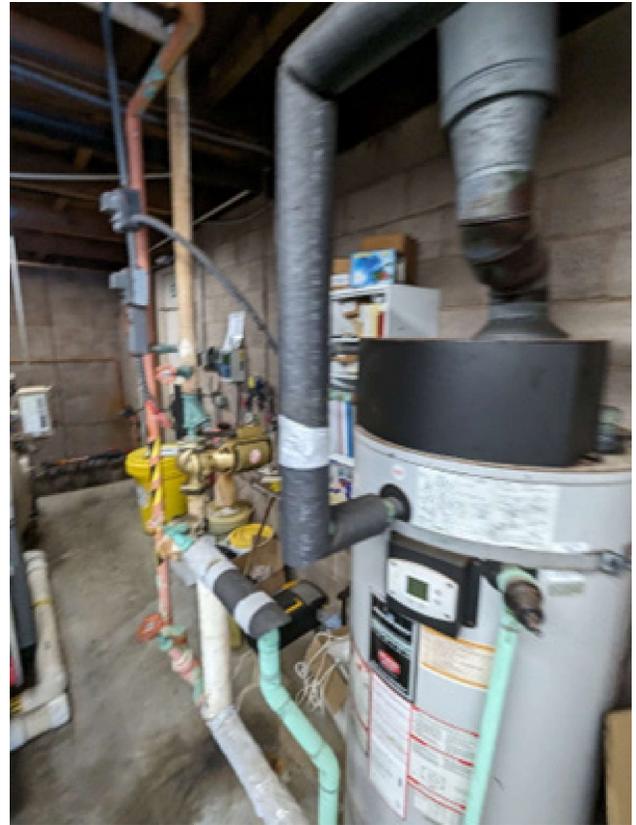
The gas-fired tank-type water heater that serves the locker rooms is located within the pool equipment room and includes a circ pump to reduce wait time for hot water. Both the water heater and the circ pump appear to have been replaced within the past 10 years. The hot from the tank is routed to a tempering valve to set a single hot water temperature distributed up high along the back wall out to all locker room fixtures. Mostly parallel with cold water distribution piping.

Gas Fired Water Heater and Tank

P3: Replace existing gas fired tank type water heater for heat pump

- Replace the existing water heater with a 119 gallon tank paired with multiple SANCO2 air source heat pumps making use of all the existing connections but using electricity instead of gas.
- The feasibility of this first will require City input on how much showering they anticipate.
- Replace thermostatic mixing valve. It is not likely that the existing mixing valve was listed to the same safety standard as a modern thermostatic mixing valve so to provide an improved level of temperature control and scald protection.

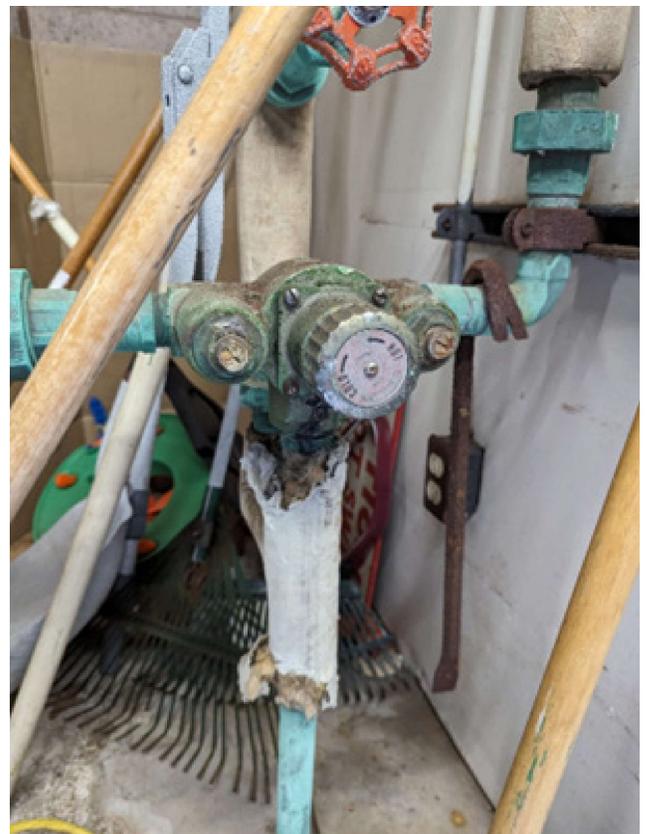
Central Thermostatic Mixing Valve beside the tank

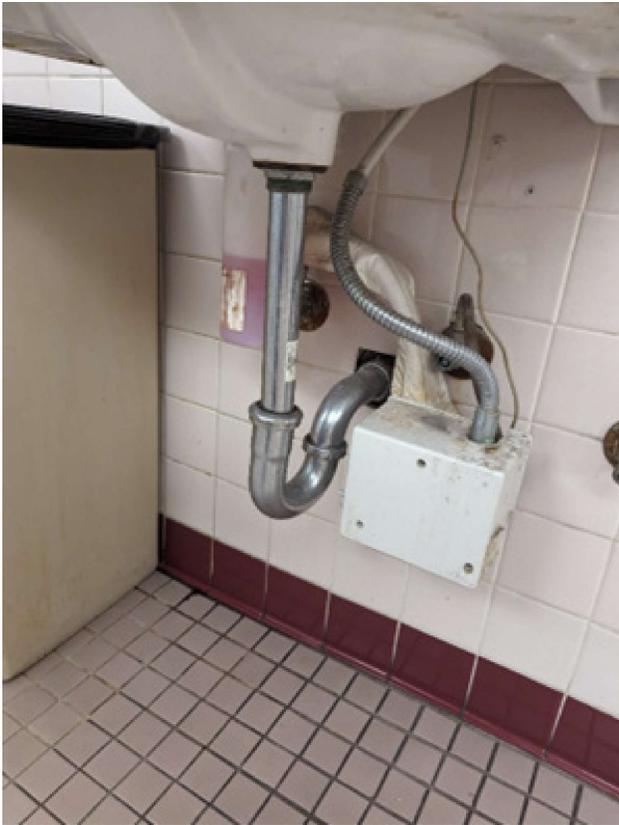
The lavatory fixtures have under counter electric tankless water heaters for handwashing.

Undercounter Electric Tankless Water Heaters

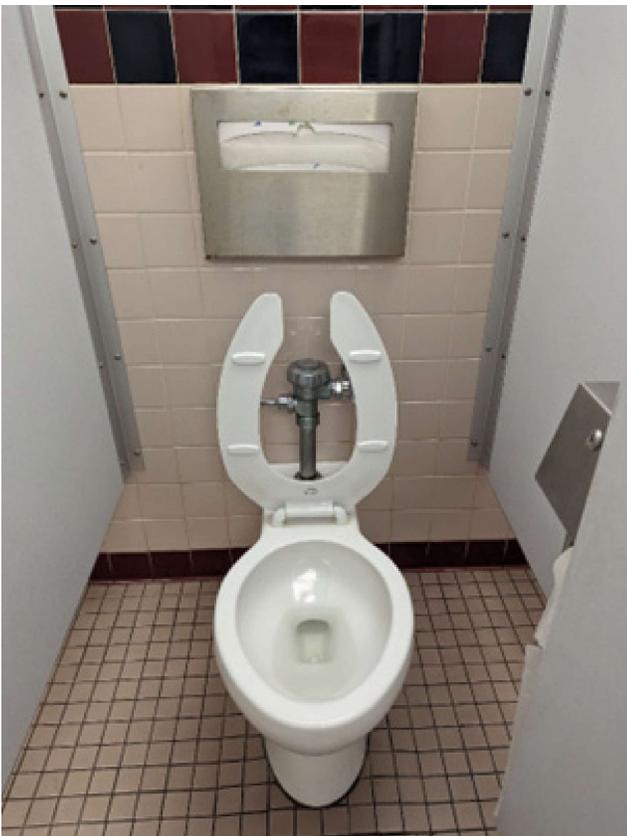
Most of the plumbing appears to be original copper and cast iron from 1968. Record drawings (1987) indicate water closets and lavatories were replaced. 1.6 GPF water closets with manual flushometers noted on site walk and the lavatories include sensor faucets (flowrate unknown)

Manual Flushvalve for Floor mounted water closets

P2: Replace Fixtures to be improved and compliant.

- This would improve user experience (sensor flush at urinals and water closets)
- Shower valves replaced with modern compliant pressure balance valves. (This may trigger required modifications of floor drains)
- Refer to attached floor plans for fixture counts.
