ARBORIST'S REPORT

For West Santa Inez Condos

San Mateo, CA

Revised June 13, 2017

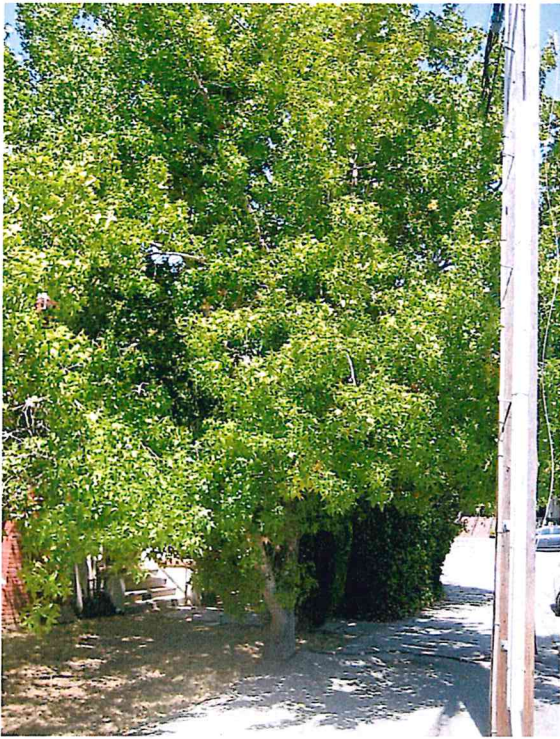
#1

Tree #	Botanical Name	Common Name	DBH	Condition	Comments	Remove
1	Liquidamber styraciflua	Sweet Gum	12"	4	Surface roots raising asphalt	X
2	Quercus agrifolia	Coast Live Oak	10"	4	Covered with ivy	X
3	Prunus cerasifera	Flowering Plum	4"	2	Covered with ivy	X
4	Quercus agrifolia	Coast Live Oak	8"	3	Covered with ivy	X
5	Quercus agrifolia	Coast Live Oak	8"	3	Covered with ivy	X
6	Acer campestre	Field Maple	6"	2	Covered with ivy	X
7	Acer campestre	Field Maple	8"	2	Covered with ivy	X
8	Malus domestica	Apple Tree	15"	2	Fungus evident	X
9	Acer campestre	Field Maple	8"/6"	3	Multi-trunk	X
10	Acer campestre	Field Maple	10"	3	Multi-trunk	X
11	Acer campestre	Field Maple	8"/6"	3	Multi-trunk	X
12	Phoenix canariensis	Canary Is. Date Palm	32"	4	Prune old fronds	X
13	Quercus agrifolia	Coast Live Oak	18"/16"	4	Next to house	X
14	Sequoia sempervirens	Coast Redwood	28"	4	Next to house	X
15	Crataegus laevigata	English Hawthorn	7"	2	Stressed	X

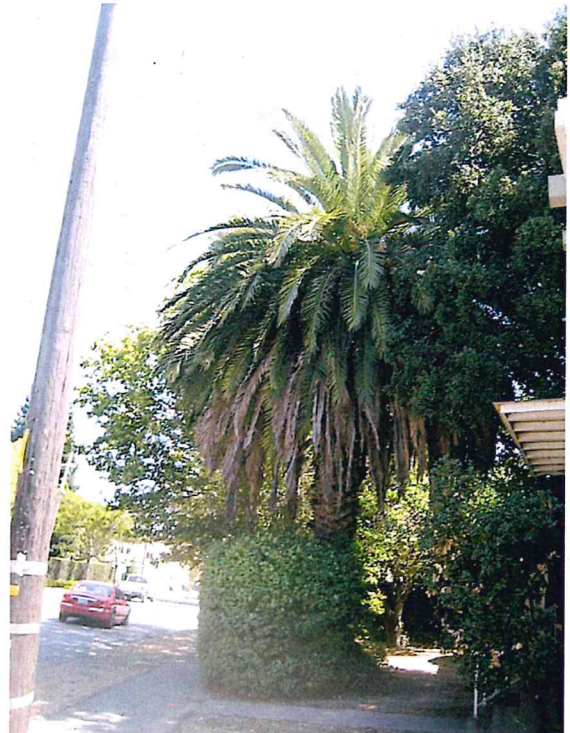
#12

SECT	DIA	BOTANICAL NAME	COMMON NAME	TO BE REPRODUCED	COMMENTS	CONDITION	HERITAGE VALUE
1	10"	LIGUARIUM STRACAPILLIA	SOFT GUM	YES	ROOTS LIFTING ASPHALT	GOOD CONDITION	NO
2	12"	QUERCUS AGRIFFOLIA	COAST LIVE OAK	YES	COVERED WITH IVY	GOOD CONDITION	YES
3	4"	PRUNUS CERASIFERA	FLOWERING PLUM	YES	COVERED WITH IVY	GOOD CONDITION	NO
4	8"	QUERCUS AGRIFFOLIA	COAST LIVE OAK	YES	COVERED WITH IVY	GOOD CONDITION	NO
5	5'	QUERCUS AGRIFFOLIA	COAST LIVE OAK	YES	COVERED WITH IVY	GOOD CONDITION	NO
6	6"	ACER CAMPESTRE	FIELD MAPLE	YES	COVERED WITH IVY	GOOD CONDITION	NO
7	8"	ACER CAMPESTRE	FIELD MAPLE	YES	COVERED WITH IVY	GOOD CONDITION	NO
8	15'	MALUS DOMESTICA	APPLE TREE	YES	FINDING EVIDENT	GOOD CONDITION	NO
9	8 1/2"	ACER CAMPESTRE	FIELD MAPLE	YES	MULTI-TRUNK	GOOD CONDITION	NO
10	10"	ACER CAMPESTRE	FIELD MAPLE	YES	MULTI-TRUNK	GOOD CONDITION	NO
11	8 1/2"	ACER CAMPESTRE	FIELD MAPLE	YES	MULTI-TRUNK	GOOD CONDITION	NO
12	32'	PHOENIX CANARIENSIS	CANARY IS. DATE PALM	YES	PRUNE OLD FRONDS	GOOD CONDITION	YES

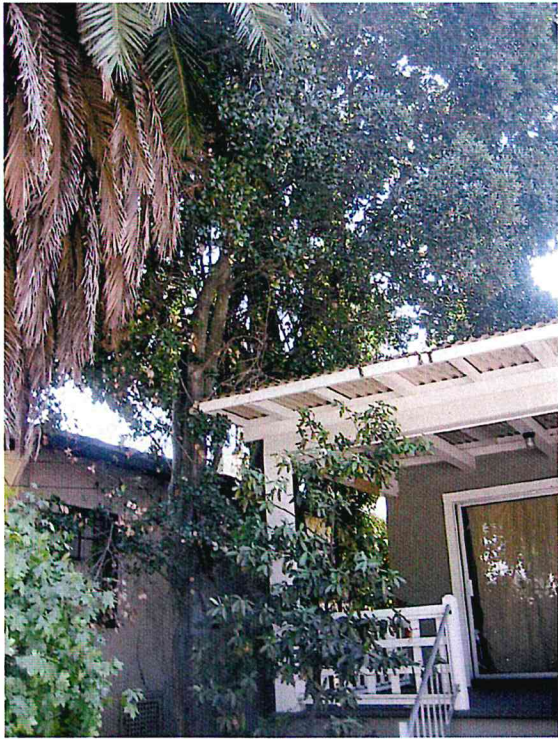
#13

13	18 1/2"	QUERCUS AGRIFFOLIA	COAST LIVE OAK	YES	ADJACENT TO HOUSE	GOOD CONDITION	YES
14	20"	QUERCUS SEMPERVIRENS	COAST REDWOOD	YES	ADJACENT TO HOUSE	GOOD CONDITION	YES
15	1'	CRATAEGUS LAEVIVENTA	ENGLISH HAWTHORN	YES	STRESSED	GOOD CONDITION	NO
16	6'	MYRTUS COMMNIS	MYRTLE	YES		GOOD CONDITION	NO
17	6"	FELDIA BELLONIANA	PINEAPPLE GUAVA	YES		GOOD CONDITION	NO
18	6"	LIGUSTRUM LUCIDUM	CALIFORNIA PRIVET	YES	COVERED WITH IVY	GOOD CONDITION	NO
19	20"	SCINUS MOLLE	CALIFORNIA PEPPER	YES		GOOD CONDITION	YES
20	12"	FIG	FIG TREE	YES		GOOD CONDITION	NO
21	6"	CITRUS SPP.	LEMON TREE	YES		GOOD CONDITION	NO
22	6"	LIGUSTRUM LUCIDUM	CALIFORNIA PRIVET	YES		GOOD CONDITION	NO
23	40"	QUERCUS SEMPERVIRENS	COAST REDWOOD	YES	NEIGHBORING PROPERTY	GOOD CONDITION	YES
24	4"	CUPRESSUS SEMPERVIRENS	ITALIAN REDWOOD	NO	NEIGHBORING PROPERTY	GOOD CONDITION	NO
25	4"	CUPRESSUS SEMPERVIRENS	ITALIAN REDWOOD	NO	NEIGHBORING PROPERTY	GOOD CONDITION	NO

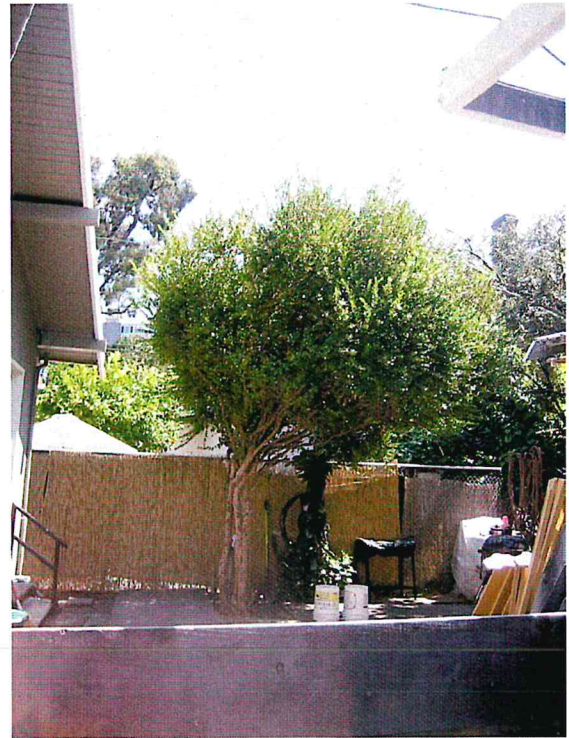
#16

16	Myrtus communis	Myrtle	6"	4		X
17	Feijoa sellowiana	Pineapple Guava	6"	3		X
18	Ligustrum lucidum	California Privet	8"	3	Covered with ivy	X
19	Schinus molle	California Pepper	20"	3		X

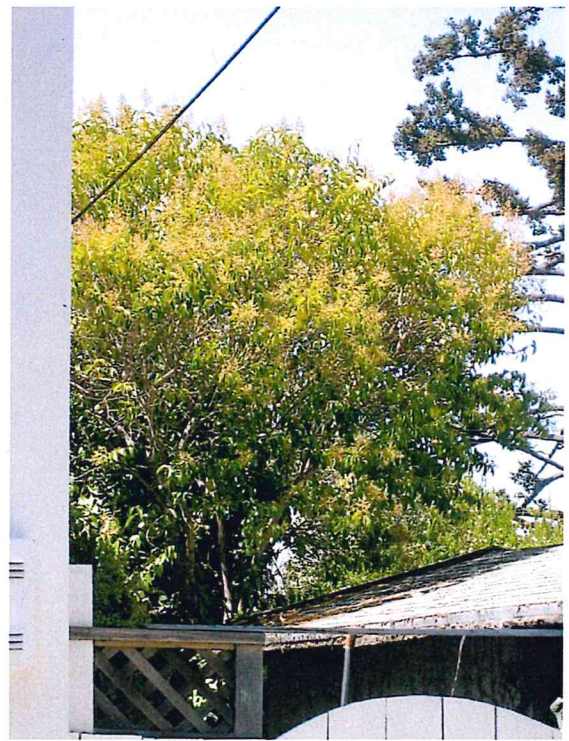
#22

20	Fig	Fig Tree	12"	4		X
21	Citrus spp.	Lemon Tree	6"	4		X
22	Ligustrum lucidum	California Privet	8"	3		X
23	Sequoia sempervirens	Coast Redwood	40"	4	Neighboring property	
24	Cupressus sempervirens	Italian Cypress	4"	4	Neighboring property	
25	Cupressus sempervirens	Italian Cypress	4"	4	Neighboring property	
26	Cupressus sempervirens	Italian Cypress	4"	4	Neighboring property	
27	Cupressus sempervirens	Italian Cypress	4"	4	Neighboring property	
28	Cupressus sempervirens	Italian Cypress	4"	4	Neighboring property	
29	Cupressus sempervirens	Italian Cypress	4"	4	Neighboring property	
30	Cupressus sempervirens	Italian Cypress	4"	4	Neighboring property	
31	Cupressus sempervirens	Italian Cypress	4"	4	Neighboring property	
32	Cupressus sempervirens	Italian Cypress	4"	4	Neighboring property	
33	Cupressus sempervirens	Italian Cypress	4"	4	Neighboring property
