Arborist Report and Tree Protection Plan

222 South Fremont Street
San Mateo, California

Uriel Hernandez
ISA Certified Arborist WE-11955A

Revised March 22, 2022

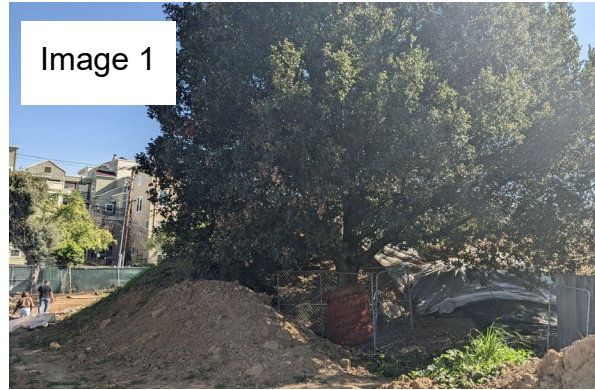
Tree #19 was a Coast live oak with a diameter of 21 inches (**Image 1**). It had Fair health and Good structure. Though it lacked a central leader, as is typical of the species, it had a seemingly stable structure and a dense canopy. There was minor dieback of the outer canopy, potentially due to current conditions. At the time of my first site visit, a small Tree Protection Zone was established by a chain link fence approximately 3-6 feet from the trunk. Additionally, netting and straw wattle was wrapped around the trunk. Soil had been piled on the surrounding area within the dripline and critical root zone (**Image 2**).

The pile of soil in the critical root zone of tree #19 is of greatest concern and should be removed as soon as possible. Appropriate Tree Protection Zones must be established for all trees near construction activities (**Table 4**).

1. Remove the pile of soil that is located on the critical root zone of Coast live oak #19.
 - a. This should be done so that no construction vehicles encroach upon the Tree Protection Zone of either tree. The vacated ground should remain uncompacted and covered with root buffers.

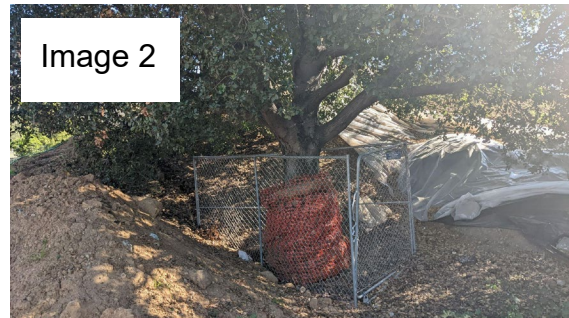
During my site visit, I observed large (greater than 12' tall) piles of soil located on top of the critical root zone of Coast live oak #19. I also observed straw wattle wrapped around tree #19's trunk. Both elements had been put in place several months ago by a previous contractor. The pile of soil is currently compacting the soil around the tree's roots (as well as tree #18's roots) and should be removed.

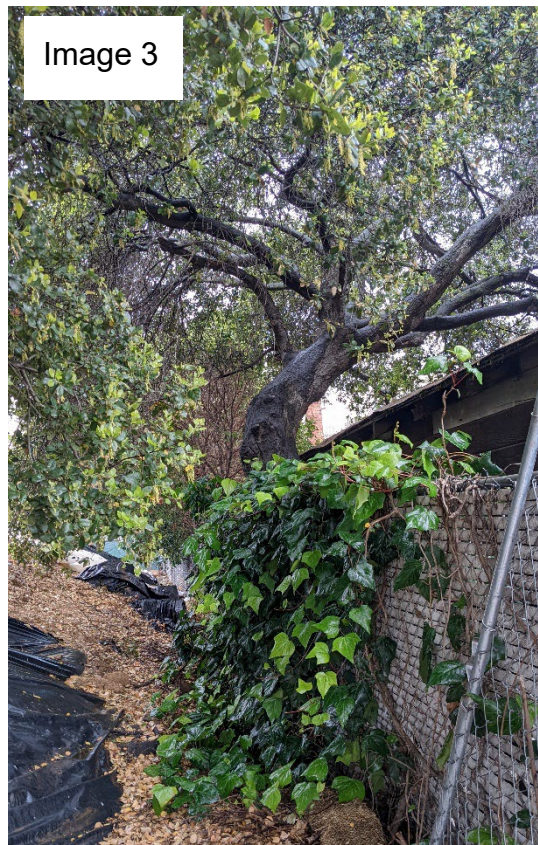
Tree #18 was also a Coast live oak located in the backyard of the adjacent 717 3rd Ave between the fence line and a backyard tool shed (**Image 3**). In the previous arborist report, tree #18 was incorrectly mapped and shown to be located where Blackwood acacia #23 is located.

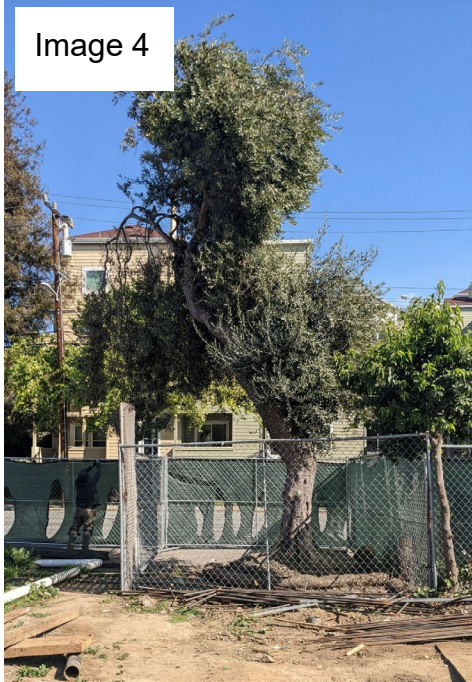
Image 4

Olive #14 had a diameter of 18 inches (**Image 4**, next page). It was in Poor health and had Poor structure. It had significant structural defects and the base of the tree had grown over the adjacent sidewalk. There was also mechanical damage along the trunk. It was located within the public right-of-way within a 3' planting strip along Fremont Street. During my site visit, a chain link fence delineated the Tree Protection Zone and was located approximately 3-7' from the trunk.

If the tree preservation recommendations in the following section are adhered to, all trees are likely to survive redevelopment. However, due to the poor condition of Olive #14, I would recommend it be removed and replaced (see Exhibit B.) A permit is required to remove or perform any pruning of a street tree.

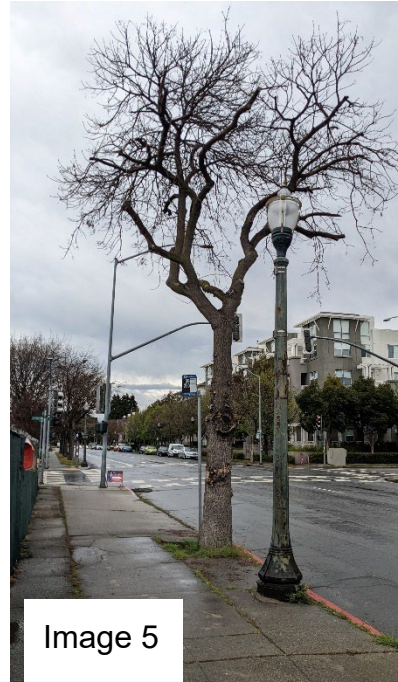
Image 5

a sidewalk cutout (**Image 5**). It was in fair health and fair structural condition, and had evidence of being previously topped. It was Protected both as a street tree and a Heritage Tree.

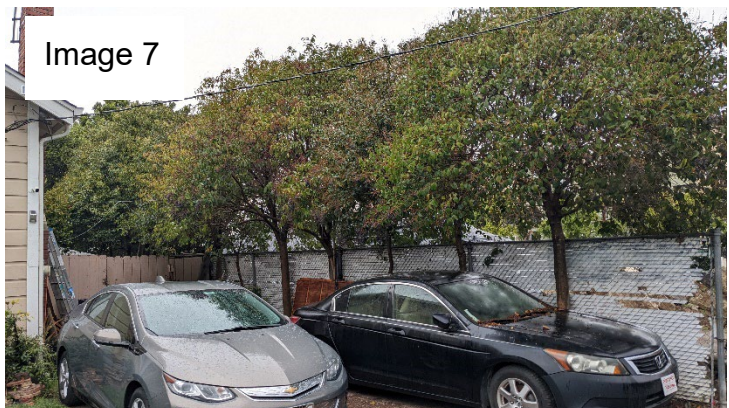
Image 7

A row of over a dozen glossy privets were located on 717 3rd Ave along the eastern fence line near the driveway (**Image 7**). Two trees (#24 and 25) had six (6) inch trunk diameters and were included in this report.
