# California Tree and Landscape Consulting, Inc.

May 25, 2022

**RE: AMENDED ARBORIST REPORT FOR HAYWARD PARK STATION  
COMPLEX DEVELOPMENT, SAN MATEO, CA**

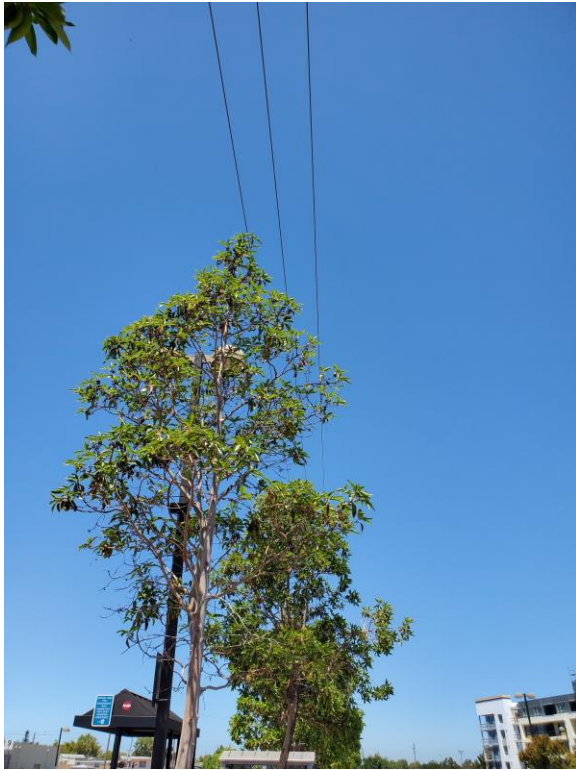
There was a row of Brisbane Box trees growing in a planting space along the westerly side of the property and the east side of the train station platform and fence. The planter width ranged from approximately 4.5 feet to 6.5 feet. All of the Brisbane Box trees along the railroad tracks were growing under electrical overhead power lines. On the south side of the property where the street bends south parallel to the railroad tracks there were trees planted that may be off property following the lot line on the plans. There were bamboo growing on the east side of the fence apparently off property and some foliage extended into the subject property by up to 5 feet.

Most of the trees were found to be in fair or good condition at the time of the inspection with only one tree #8966 being in poor condition. The longevity of the trees is low as most of the upright Brisbane Box trees were growing under power lines and will need to be reduced by pruning for wire clearance. Most of the trees appeared to be planted in a confining circular root barriers around the root ball which will limit the root growth and root structure, and may limit the mature trunk size as the trees grow larger.

Brisbane Box trees under power lines along railroad tracks

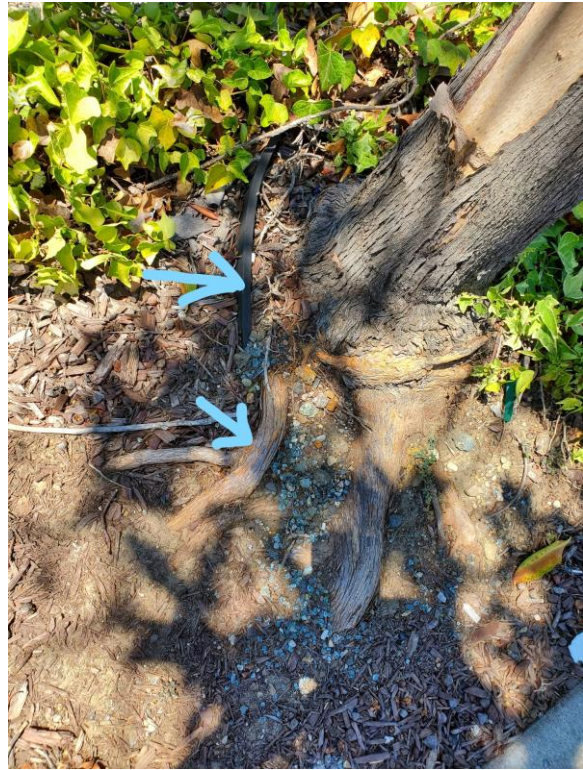
barriers stuck up above the soil and some were buried beneath the soil and evident from soil moved away. A few trees had surface roots that had grown over the barrier and some of the barriers had failed with roots growing through the barrier material.

Root barrier and roots grown over barrier

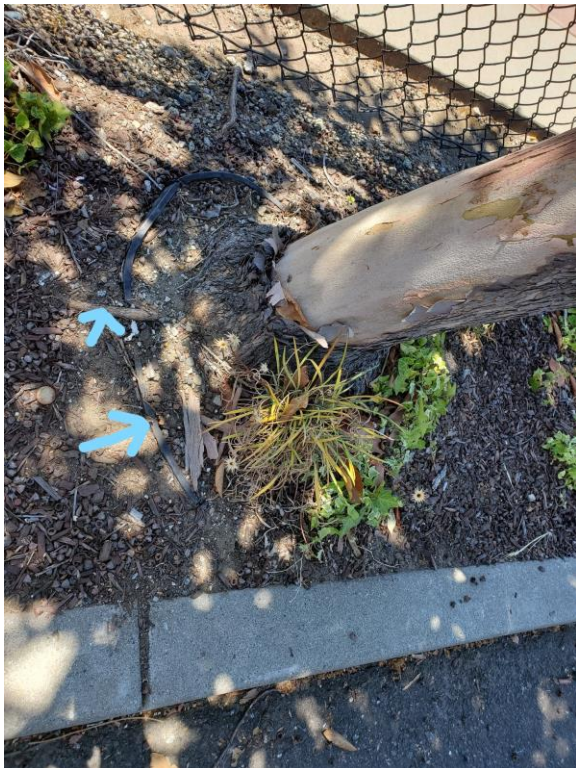
Root barrier and roots grown over barrier

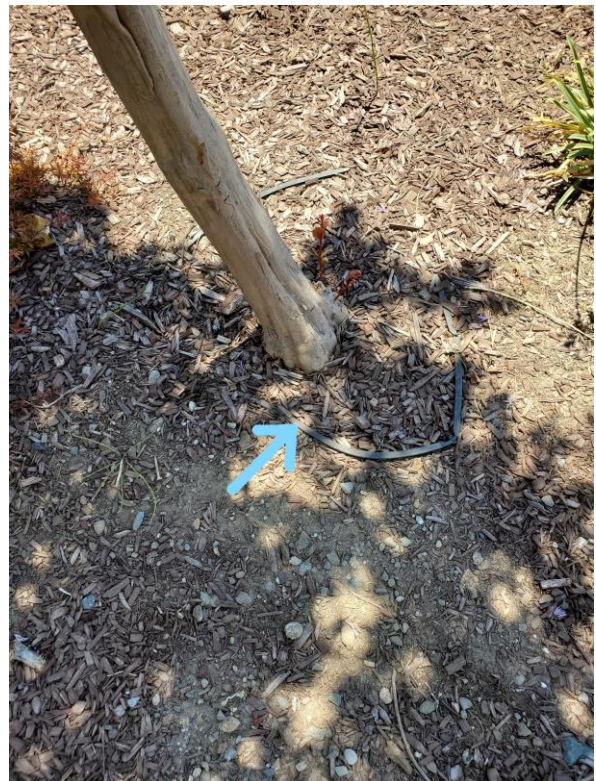
Root barrier and roots grown over barrier
