Tree Inventory, Assessment and Protection Report

222 E. 4th Street
San Mateo, CA

July 17, 2020
Revised October 20, 2021

Lane Partners, LLC

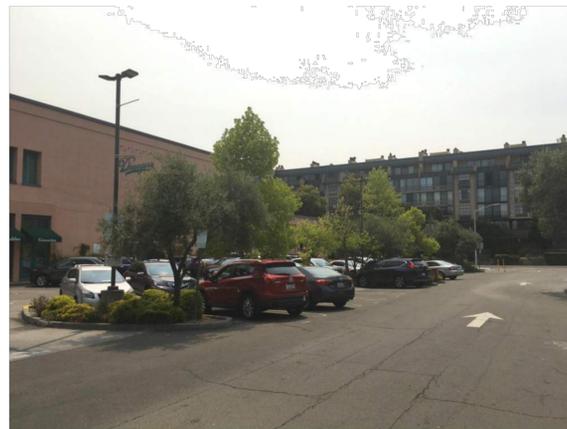
C2: N. Ellsworth Olives and Tulip Trees

Most of the trees have fair suitability for preservation except for the tulip poplars. All the tulip poplars are poorly suited for retention due to pest problems and their condition. At least three olives are in raided planters with two at the corner of 4th and B and one just inside the property near the corner of 4th and N. Ellsworth. These trees have good suitability for retention or could successfully be relocated.
