## Att 6 - Property Report

# Inspection Report

22 De Sabla Road & 29 Baytree Way  
San Mateo CA 94402

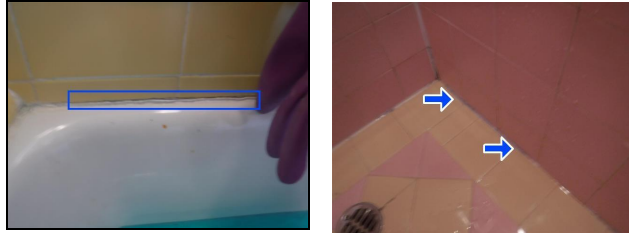
3.4 Item 1(Picture)

(1) The grout and/or sealant around the hallway bathroom shower or tub for 22 De Sabla and 29 Baytree has begun to deteriorate and/or is missing. Recommend this be repaired to prevent water damage.
