Structural Cost Estimate Narrative and Conceptual Retrofits

Date: 02/27/2024
By: ITD
Project: Joinville Swim Center

Joinville Swim Center ASCE 41-17 Tier 1

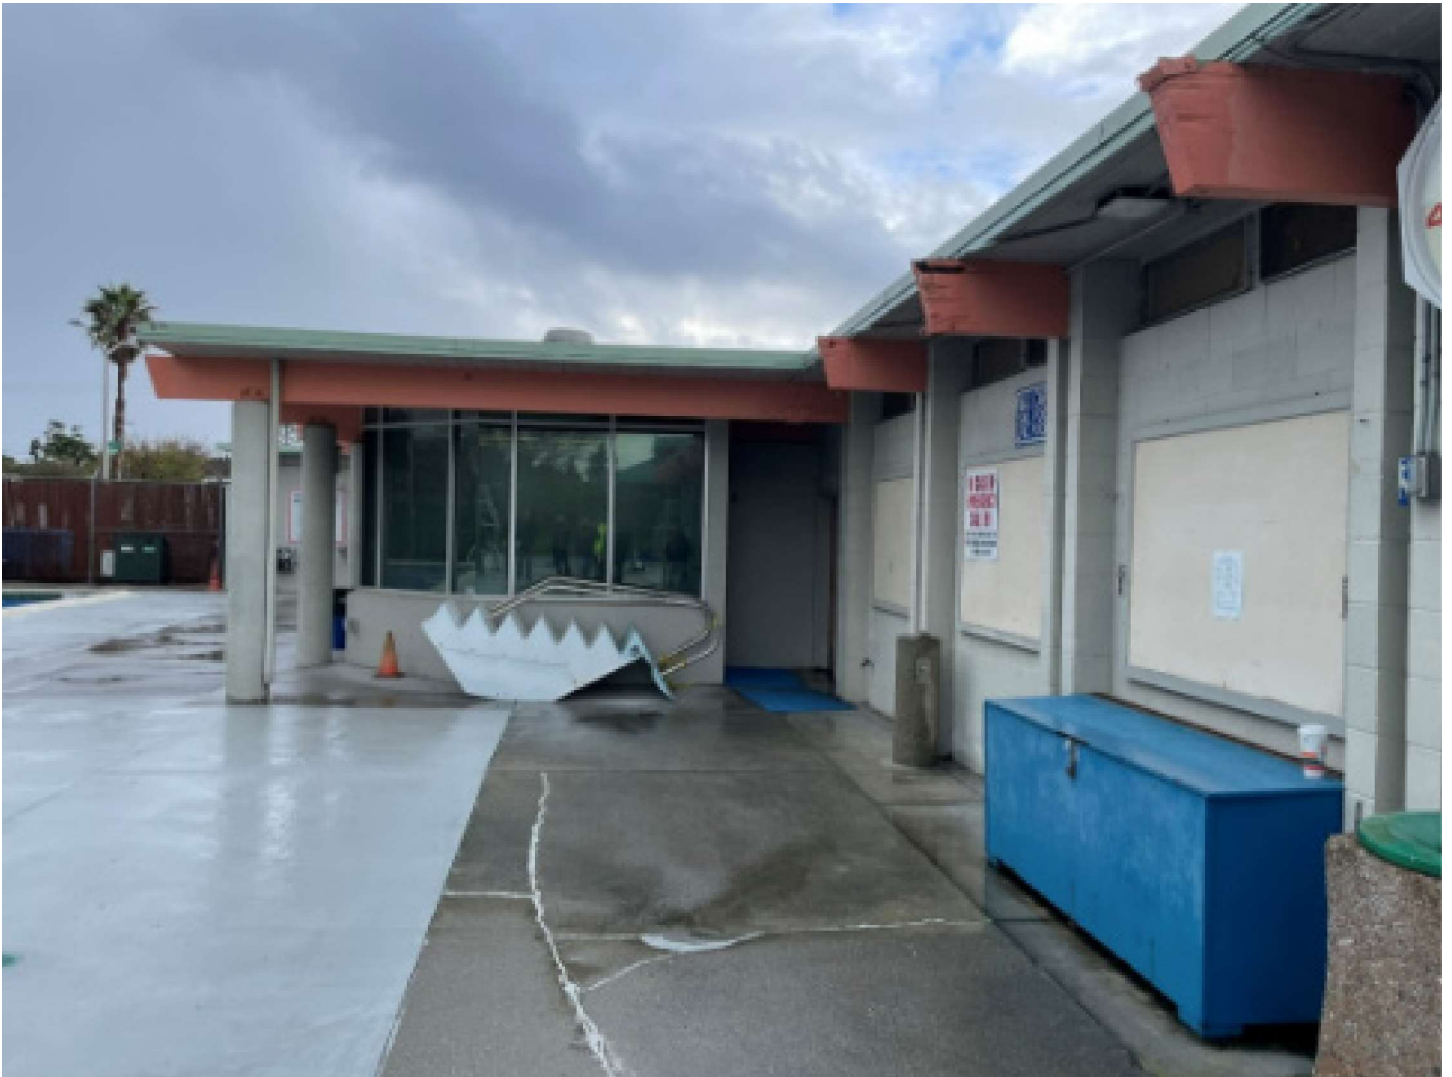
Figure 5. Typical Exposed Glulam Beams Showing Water Damage

- Existing beam ends show signs of decay and rot. While not a structural concern currently, without mitigation the rot could spread and become an issue. The ends of all exposed beams should be cut off to remove the existing rot and then capped to prevent future water infiltration. A waterproofing consultant should be engaged to develop these details.

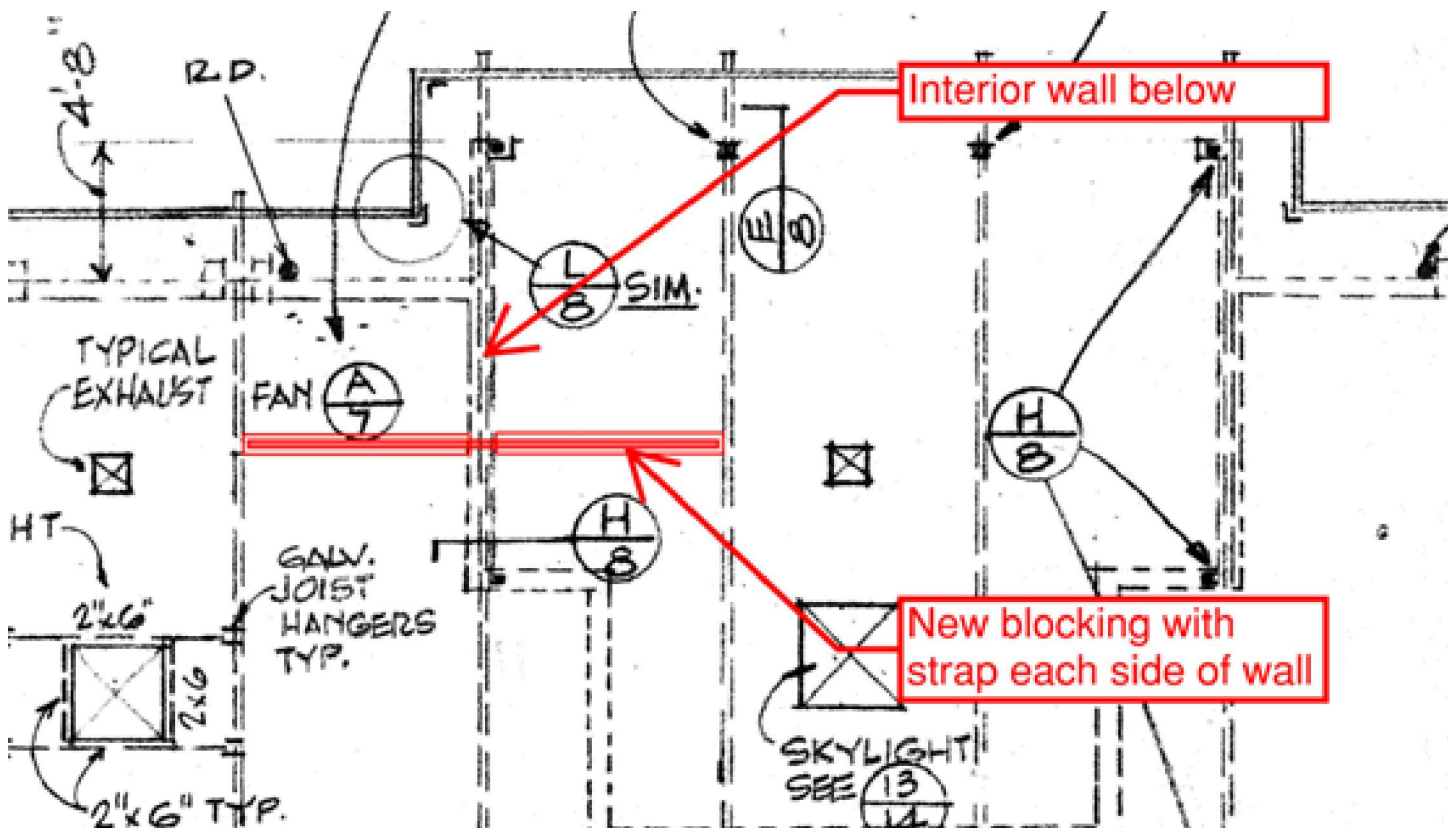
Item 1 – Modify existing wall anchorage details at interior walls (Priority 1)

- Provide 3x8 blocking each side of existing wall at 4' o.c. over length of wall. Extend blocking to next wood beam. Provide strap on top of roof sheathing with nails into the new blocking. Provide framing anchors each end of new blocking to existing wall or existing beam.

- Where beam framing is parallel to existing exterior walls (see figure below with highlighted walls), provide new blocking and hold downs with thru bolt at 4'-0" o.c.

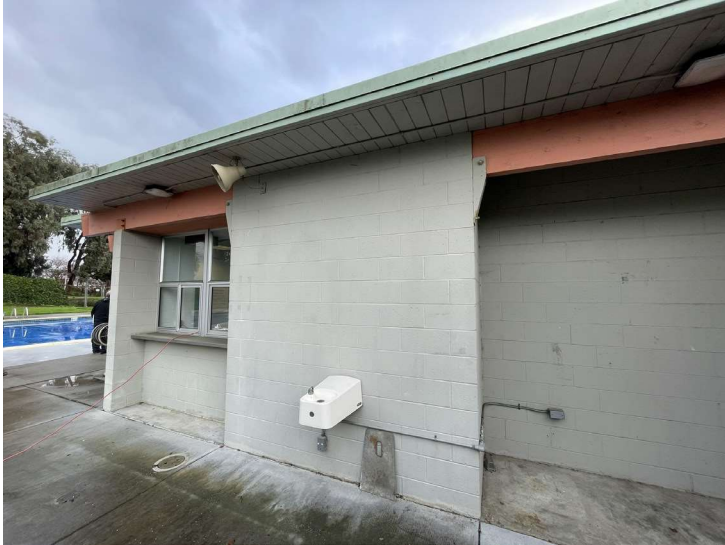
IMAGE A:

BUILT CONDITION
VARIES FROM AS
SHOWN HERE. SEE
IMAGE A

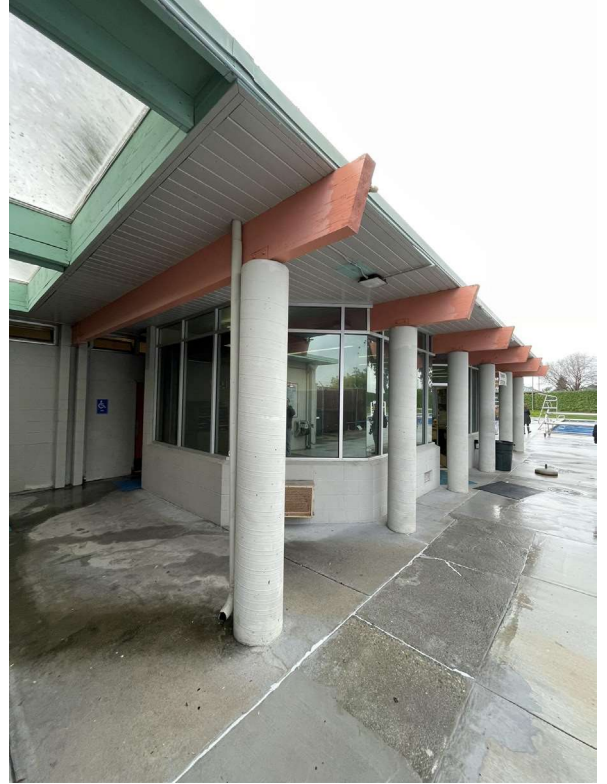
IMAGE D:

NEW ROOF EXPANDED
WITH NEW GLULAMS AND
CONCRETE COLUMNS
ADDED IN 1987.
SEE IMAGE D & IMAGE E

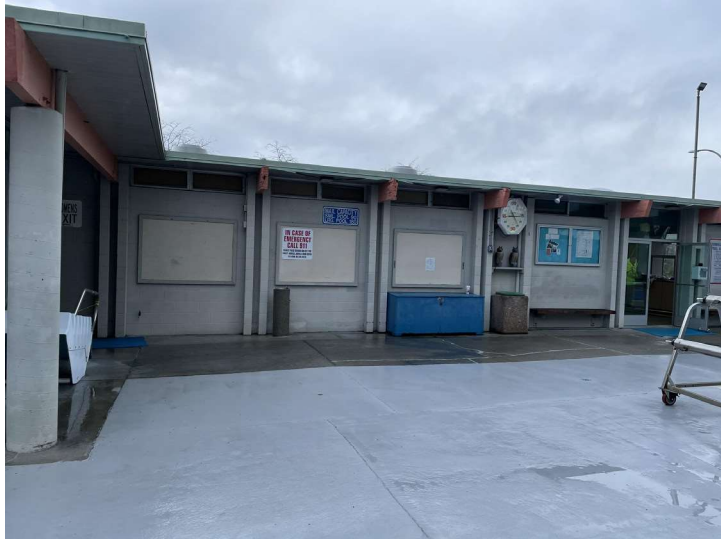
IMAGE B:

WALLS DO NOT GO
FULL HEIGHT, TYP
WHERE SHOWN IN
GREEN, SEE IMAGE B

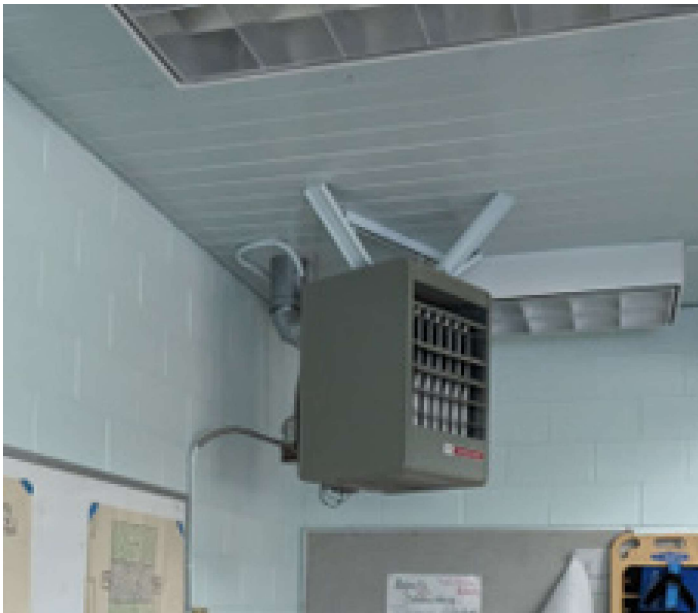
The meeting room off the pool deck has a gas-fired unit heater (as mentioned above). There is also a small kitchenette with an electric range and oven as well as a residential range hood.

Meeting room unit heater

All of the equipment installed is beyond its useful life, except for the newly installed gas-fired unit heater. All of the existing mechanical equipment should be removed and replaced. The gas-fired unit heaters are not appropriate for the spaces they serve, including the new one.

The meeting room off the pool deck could have the same system type as the adjacent spaces: a filtered supply fan providing mechanical ventilation and a split system providing space conditioning. The ventilation can be relieved passively through a roof vent at the existing roof location in that space.

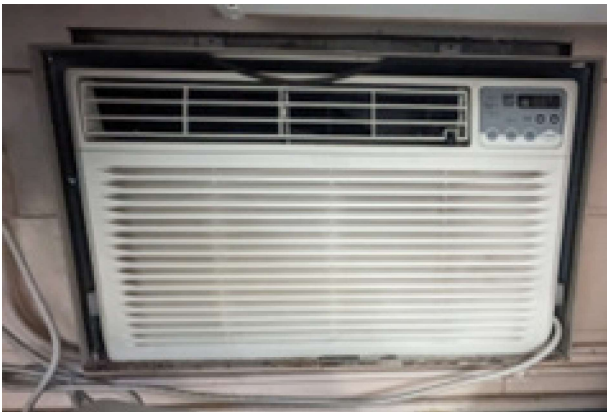
Wall mounted PTHP unit

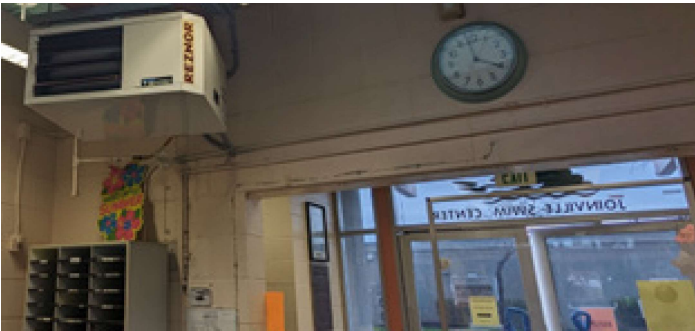
The main office space has a newer ceiling hung gas-fired unit heater. The gas-fired unit heater that was replaced, was moved into the meeting room off the pool deck.

Office unit heater

The open office space can be provided with a supply fan sized to provide the code required ventilation for the space type but will likely be increased to provide the locker room make-up air. This would be untempered but filtered air. If the building is occupied in the winter, a small electric resistance duct coil could be added to temper the mechanical ventilation in the winter if needed. The space conditioning for the open office space and private office space could be split systems. Each space could have a high wall split system with one shared outdoor heat pump either ground mounted and caged or on the roof.

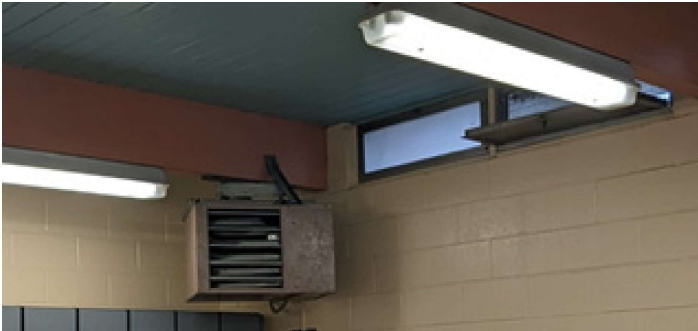
The locker rooms have exhaust vents through the roof with operable windows for natural ventilation and gas-fired unit heaters. The unit heaters in the locker rooms have started to rust and the damper blades are corroded.

Locker room gas unit heater and natural ventilation

The locker room exhaust fans are propeller fans inline with the roof, exhausting out with a weather cap. These could be replaced with new upblast exhaust fans with fully insulated and weather proofed penetrations. The exhaust fan make-up for the locker rooms can be provided by cascading the mechanical ventilation air required to be provided to the open office and lobby spaces.

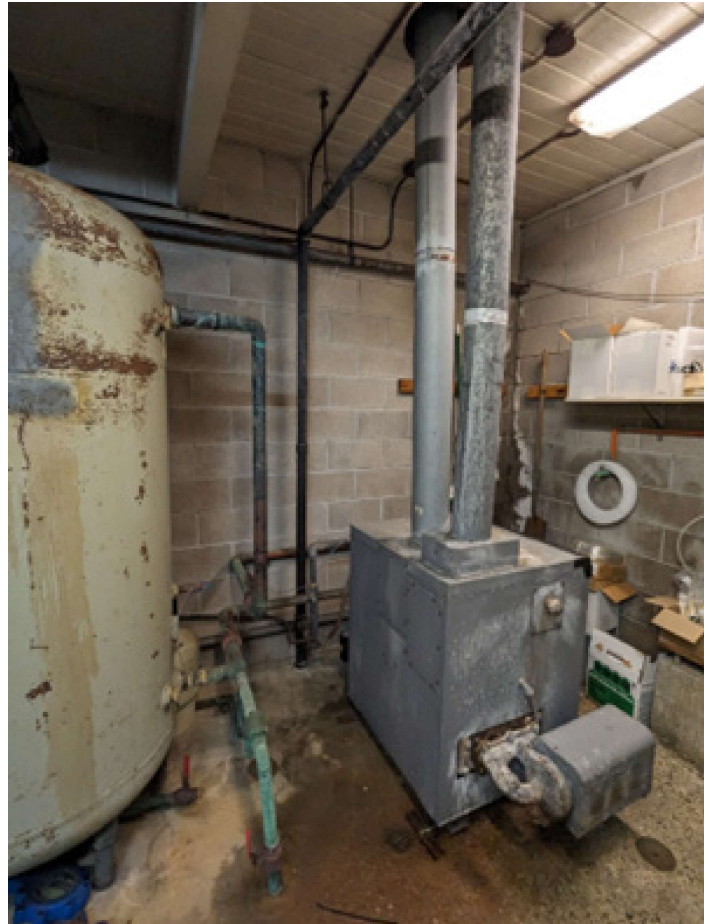
Most of the plumbing piping appears to be original copper and cast iron from 1968. Water heaters are located within the pool equipment room. The system is comprised of a large storage tank (365 gallon) paired with a gas fired water heater and circulator. The water heater was manufactured in 2004 (per the nameplate). The existing storage tank was replaced because it was leaking but the water heater remains and operates well enough (based on site discussions with the maintenance staff).

Gas Fired Water Heater and Tank

P3: Remove existing gas fired water heater and replace it with an electric heat pump

- The large tank that was recently replaced could be repurposed with multiple SANCO2 air source heat pumps making use of all the existing connections but using electricity instead of gas.
- The feasibility of this first would require City input on how much showering they anticipate to determine peak usage. This estimate should consider the installed condition when users actually enjoy the hot shower amenities.

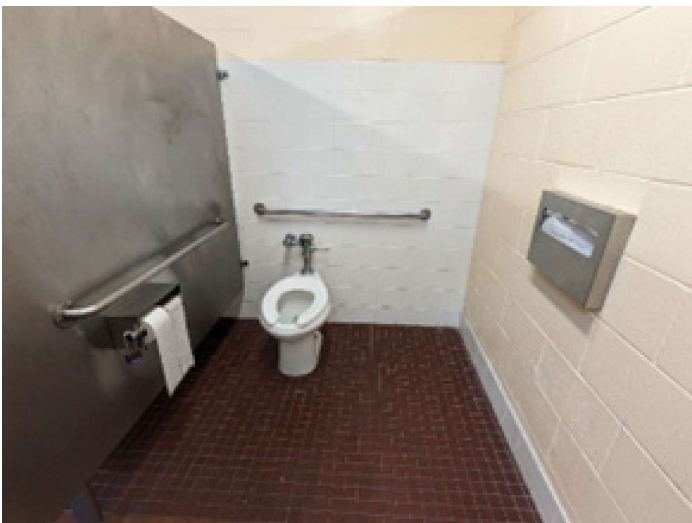
Water Closet (Floor Mount, Flush valve)

All fixtures appear to be original. Showers are operated by a single valve for each head (no compliant pressure balance valve). There is a kitchenette in the building but they said it is rarely used. A sink would likely make the space more appealing for group events.

P2: Replace Fixtures to be improved and compliant.

- This would improve user experience (sensor flush at urinals and water closets)
- Shower valves replaced with modern compliant pressure balance valves. (This may trigger required modifications of floor drains)
- Refer to attached floor plans for fixture counts.

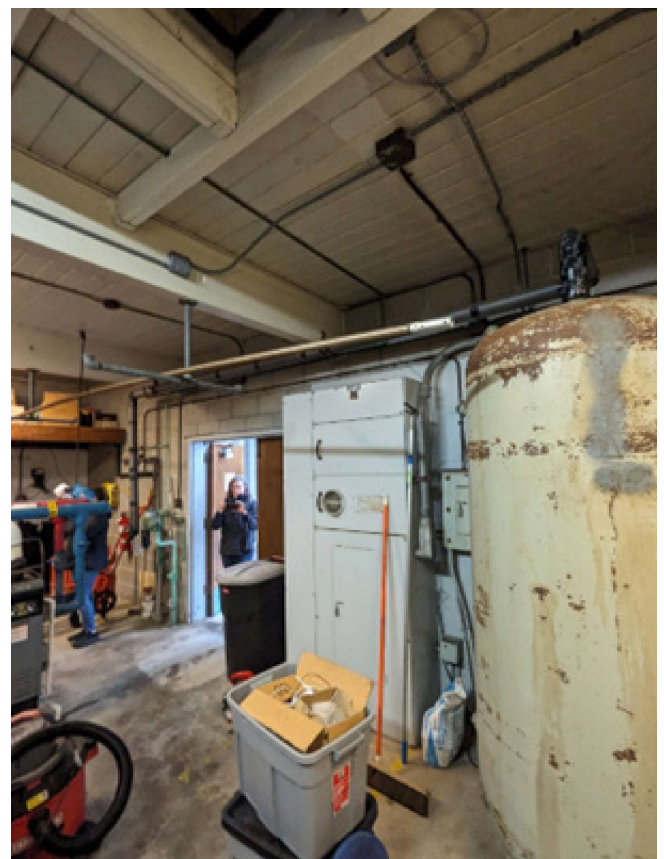
The hot water from the tank is routed to a tempering valve to set a single Tempered temperature distributed below slab to all showers parallel to the cold water distribution piping. All water distribution (cold and tempered occurs below slab only rising up within tiled walls to serve the showers. There is no circulator to reduce the wait time for hot water and this seems to be the largest pain point for the users. Copper piping in mechanical room is green in places (due to the pool chemicals in the air) but appears to be in good condition. No distinct history of plumbing leaks or piping failures has been reported. Below grade sanitary piping has no history of severe blockages besides the occasional hair ball from the showers (based on site discussions with the maintenance staff).

Gang Shower Thermostatic Mixing Valve (green copper)

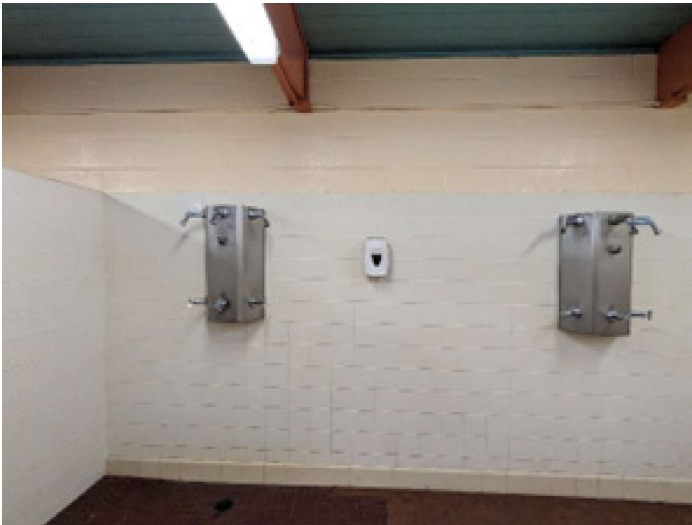
Stainless Steel Single Temperature Showers

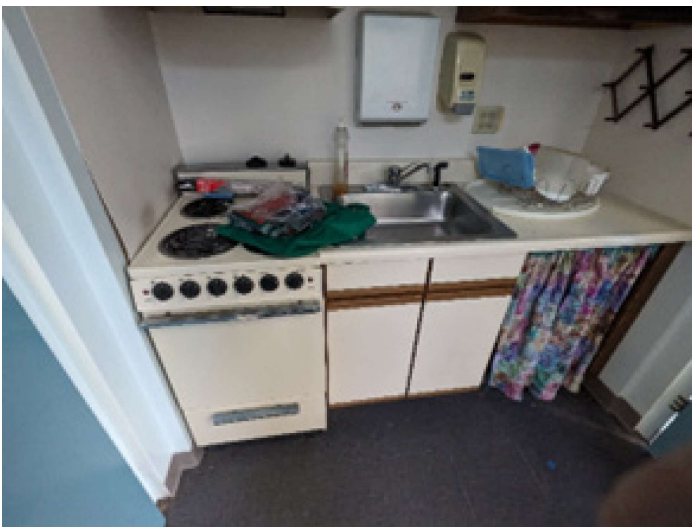
Existing Kitchenette

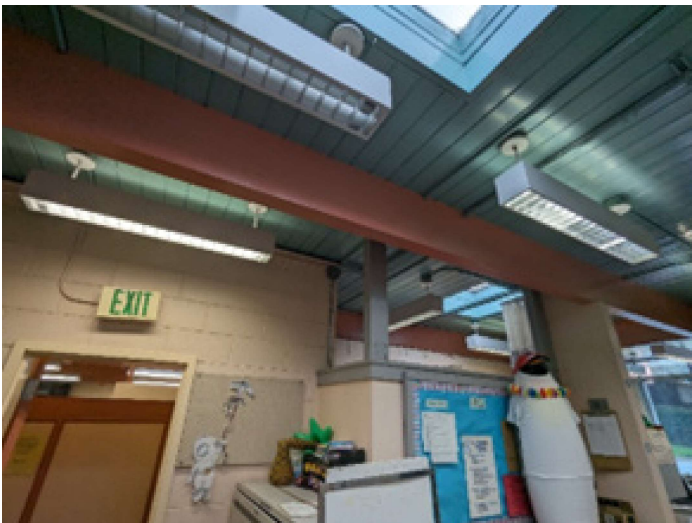
Ceilings photo Indicating limited easy pathways for piping

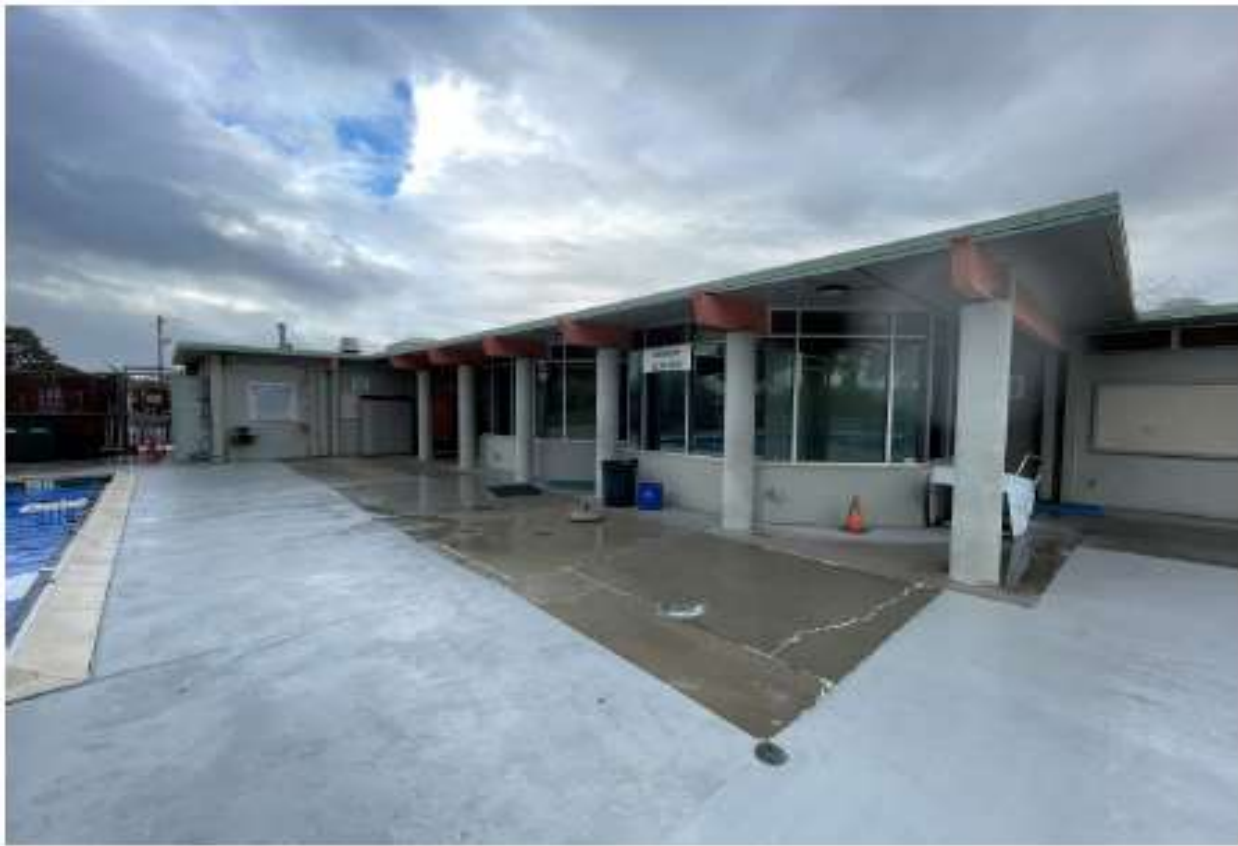
Figure 10: Extended roof area from 1987 Phase 2 improvements
