# **DRAFT PHASE I ENVIRONMENTAL SITE ASSESSMENT**

**200-222 EAST 4<sup>TH</sup> AVENUE  
SAN MATEO, CALIFORNIA**

Project Number: WR2671

May 2, 2019

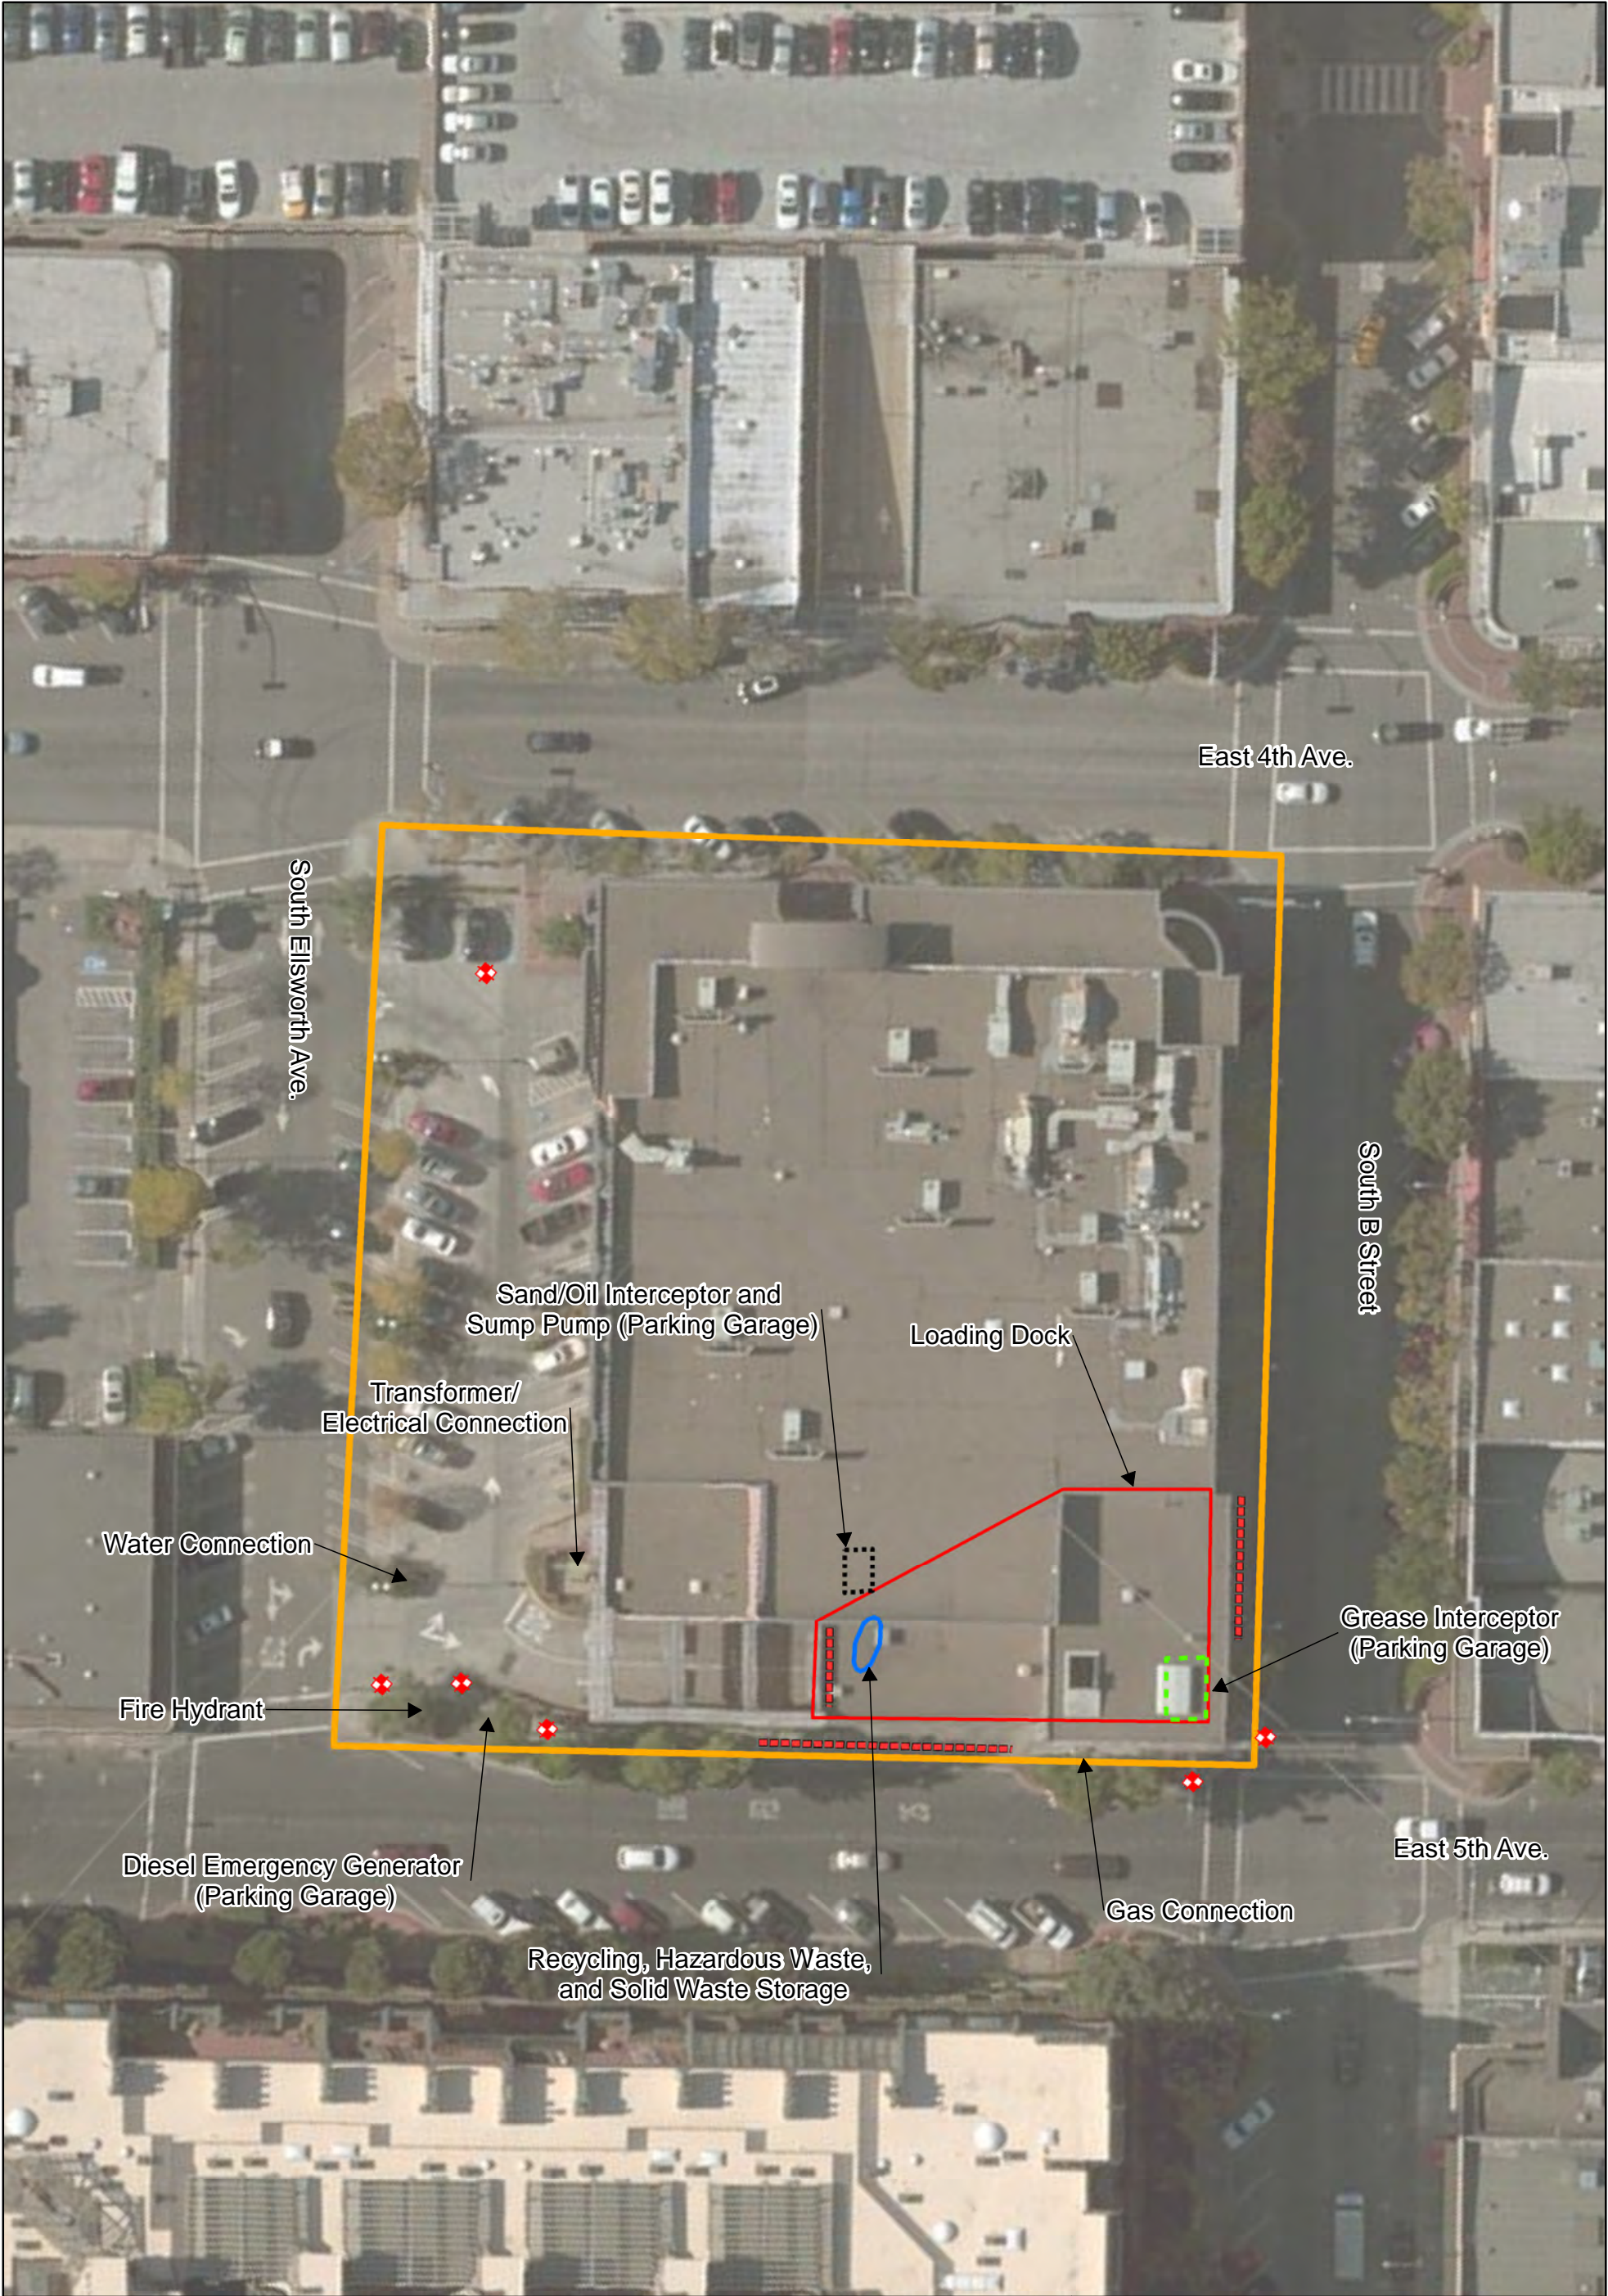
<b>Legend</b> <div><div><div> Storm Drain</div><div> Trench Drain</div><div> Grease Interceptor (Parking Garage)</div><div> Loading Dock</div></div><div><div> Recycling, Hazardous Waste, and Solid Waste Storage</div><div> Sand/Oil Interceptor and Sump Pump (Parking Garage)</div><div> Approximate Site Boundary</div></div></div>		<b>Site Layout Map</b> 200 East 4th Avenue, San Mateo, California	
		<b>Figure</b>	
WR2671-01		April 2019	
		<b>2</b>

A summary of the Site reconnaissance is provided in **Table 2** below, and locations of pertinent findings are depicted in **Figure 2**. Photographs of pertinent findings and Site features observed during the reconnaissance are provided in **Appendix H**.
