## Preliminary Arborist Report

477 9<sup>th</sup> Avenue  
San Mateo, CA 94402

May 16, 2022

TREE DISPOSITION NOTES AND LEGENDS **L-5.2**

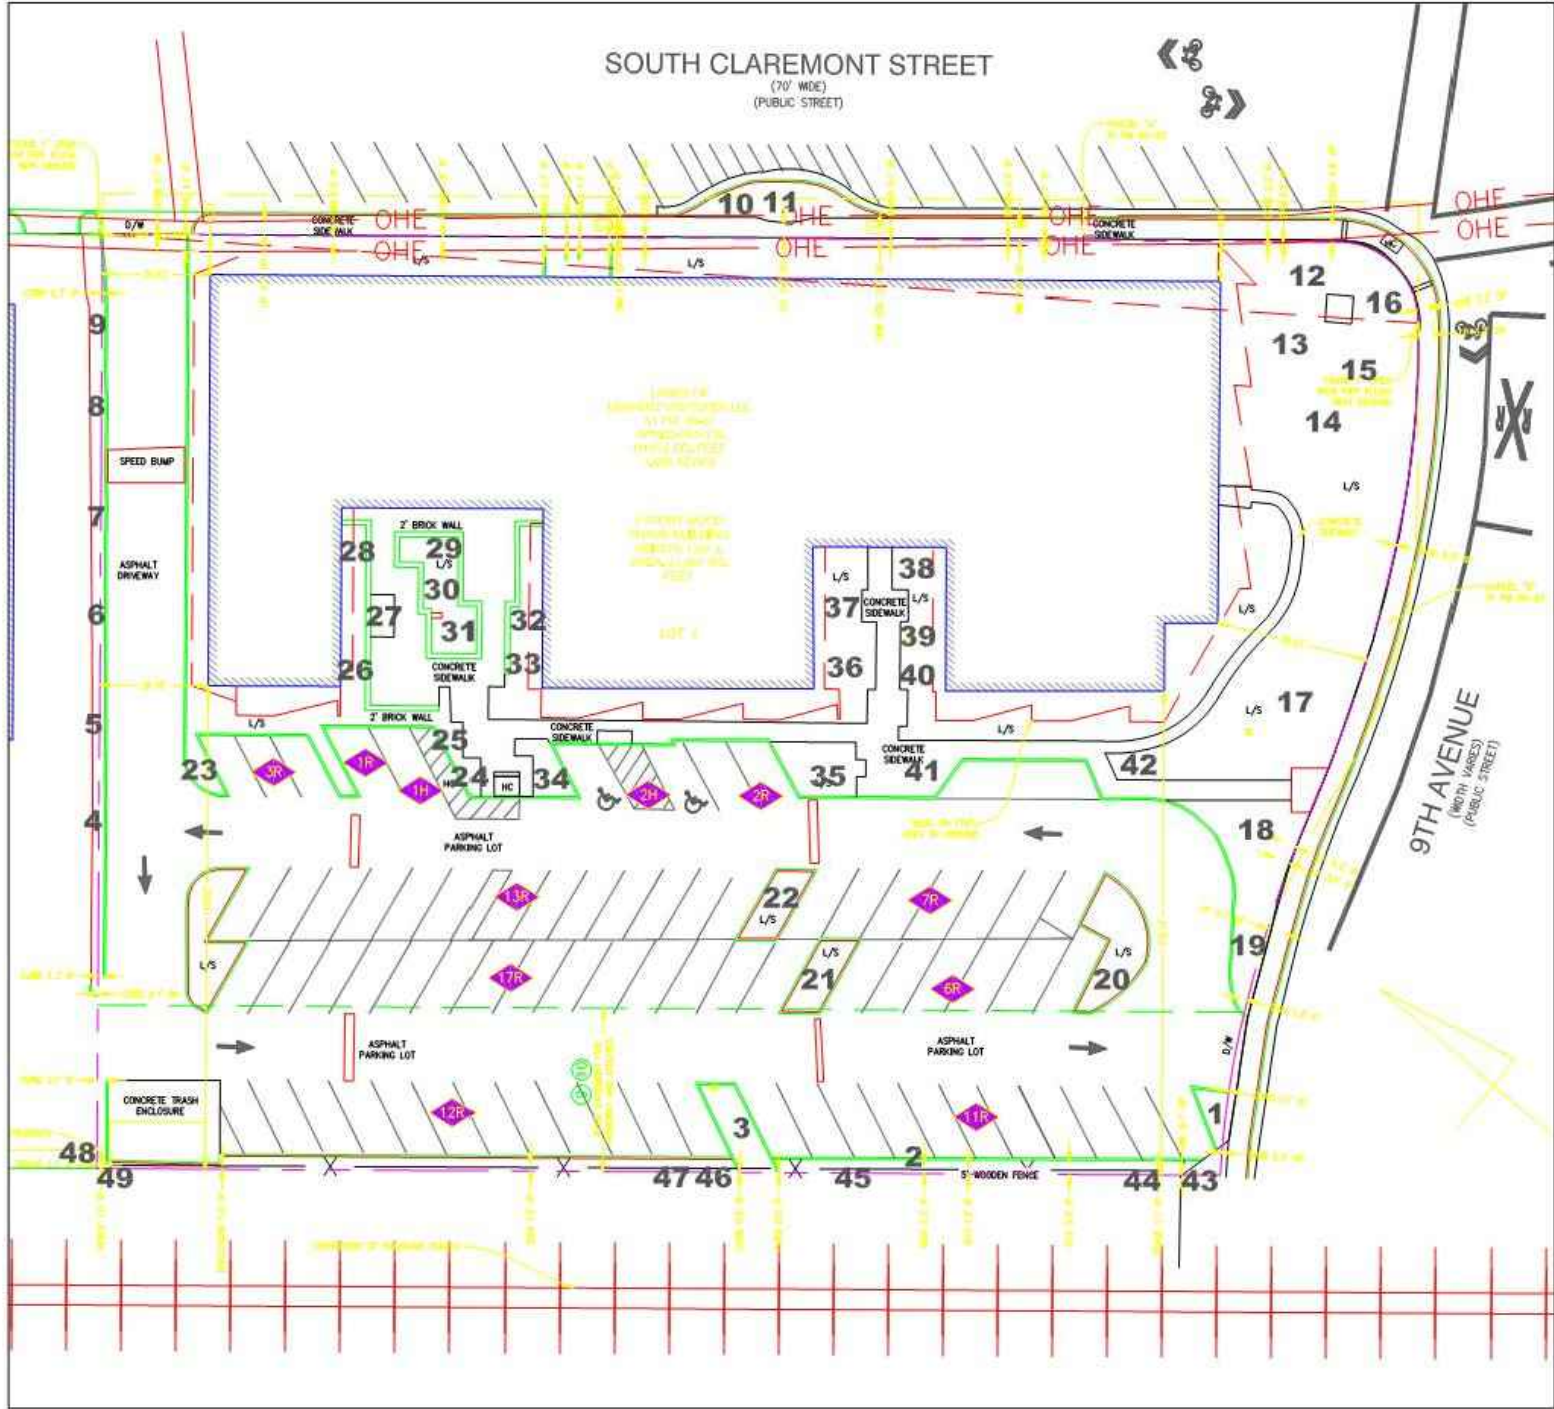
**Tree Assessment Plan**

Tree No.	Species	Trunk Diameter (in.)	Protected Tree?	Condition 1=poor 5=excellent	Suitability for Preservation	Comments
1	Ginkgo	3,3,2	No	2	Low	Multiple attachments from base; west leader mostly dead.
2	Chinese elm	19	Yes	3	Moderate	Lean to east; restricted root space; multiple attachments at 8 ft; metal pole embedded in trunk to 3.5 ft.
3	Chinese elm	22	Yes	4	Moderate	Multiple attachments at 8 ft; 7 ft wide planting space; full canopy; minor dieback in upper crown.
4	Silver dollar gum	19	Yes	3	Low	3ft planting space; sparse canopy; slightly one sided to west.
5	Silver dollar gum	22	Yes	3	Low	Codominant at 10 ft; 3 ft planting space; sparse canopy.
6	Silver dollar gum	15	Yes	3	Low	3 ft planting space; sparse crowded canopy; one sided to west.
7	Silver dollar gum	36	Yes	3	Moderate	Codominant at 10 ft; trunk fills 3 ft planting space; broken branch in canopy.
8	Silver dollar gum	28	Yes	3	Moderate	Codominant at 10 ft; trunk fills 3 ft planting space.

9	Silver dollar gum	31	Yes	3	Low	Codominant at 12 ft; pruned for utility lines; trunk fills 3 ft planting space.
10	Purpleleaf plum	3,3,3	Street Tree	4	Moderate	Multiple attachments at 2 ft; full canopy; young; growing under canopy of #11.
11	Valley oak	56	Heritage Street Tree	3	Moderate	Codominant at 10 ft; beehive in southeast stem; cavity with decay on southwest stem; topped for utility lines.
12	Olive	12,11,9	No	4	High	Multiple stems at 1 ft; topped for lines; full dense crown.
13	Olive	10,7,6,5,4	No	3	Moderate	Multiple attachments at 1 ft; 6 in stem has significant decay; suppressed on east; one sided to west.
14	Olive	9,6,5	No	3	Moderate	Multiple attachments at 1 ft; suppressed on east; one sided to west.
15	Olive	9,9,8,5	No	4	Moderate	Multiple attachments at 1 ft; topped; full crown.
16	Blackwood acacia	41	Yes	3	Low	Codominant at 5 ft; slight lean to south; slight separation in crown; roots cut at sidewalk on south.
