Structural Cost Estimate Narrative and Conceptual Retrofits

mack5 was requested to carry out a Conceptual Design Cost Plan for the proposed renovation of existing Martin Luther King Community Center, located at 725 Monte Diablo Ave., San Mateo, CA 94403.

**(E) Building Remodel & Upgrade
Martin Luther King Community Center**

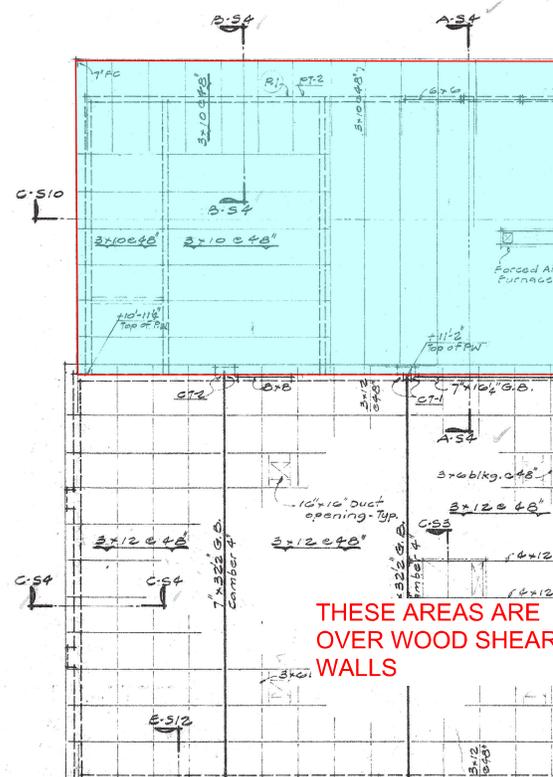
Therefore, wood shear stress deficiency is present

THESE AREAS ARE OVER WOOD SHEAR WALLS

THESE IS AREA OVER MASONRY SHEAR WALLS

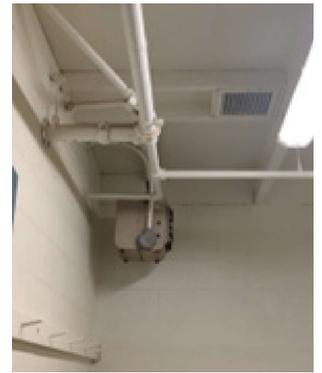
Family Changing Room Unit Heater

Assuming the interior program and spaces remain, the existing equipment shall be replaced in kind with an electric version if there is a gas connection existing. However, load and airflow calculations shall be completed prior to selecting equipment. The sizes listed here are based on the existing equipment heating capacities. When moving to all-electric, heat pump equipment is the most likely replacement for gas equipment. Heat pumps provide both heating and cooling. If cooling is not desired, it can be locked out at the unit controller. All heat pumps shall utilize R-32 or better refrigerant.

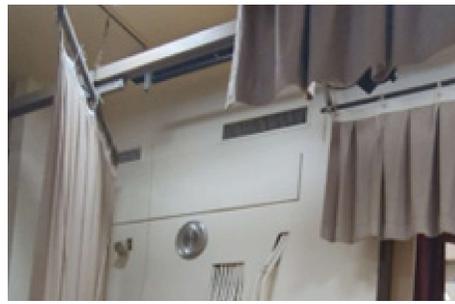
Stage Supply Air Grilles

The existing horizontal furnaces shall be replaced with high static ducted fan coils. Ductwork shall be cleaned and reused if it is in good condition. All air outlets and inlets shall be replaced with new. Balancing dampers shall be added where needed to correctly balance the systems. The fan coils shall have refrigerant piping from the unit to the heat pump outside. Each zone shall have a dedicated heat pump. The central supply fan used for ventilation shall be replaced with new and all ductwork associated shall be replaced. The ventilation ductwork shall have a filter box in-line, downstream of the fan, and it shall be easily accessible for filter changes. The filter box shall be capable of housing a MERV 13 filter and a carbon filter. The carbon filter would only be installed in a wildfire or smoke event.

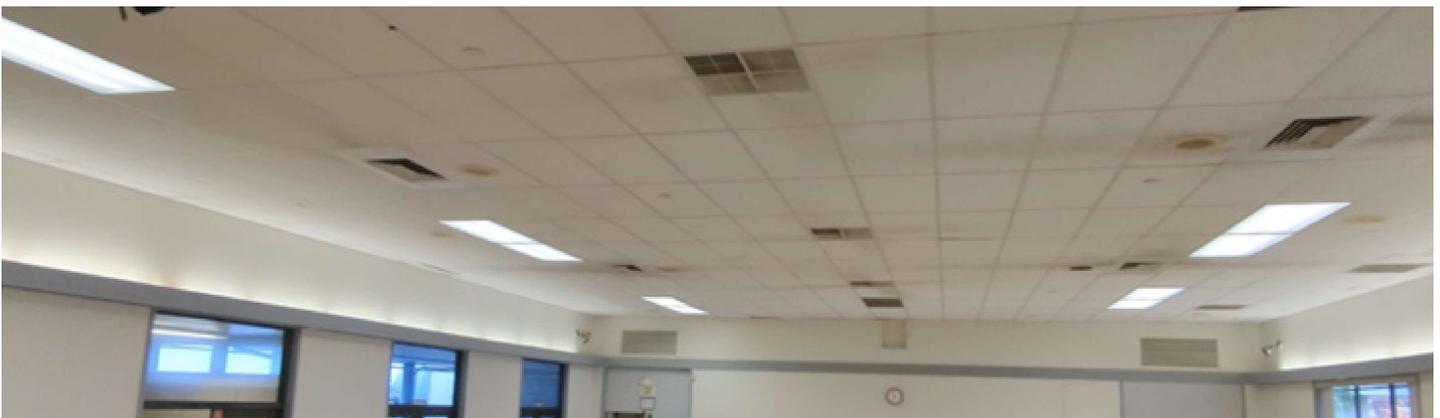
Multi-Purpose ceiling diffusers
