Tree Inventory, Assessment and Protection Report

222 E. 4th Street
San Mateo, CA

July 17, 2020
Revised October 20, 2021

Lane Partners, LLC

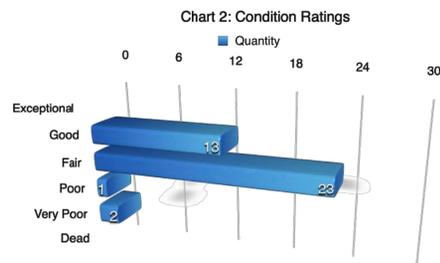
Most of the tree are in fair condition with thirteen good, one poor, two very poor, and the remaining twenty-three in fair shape.

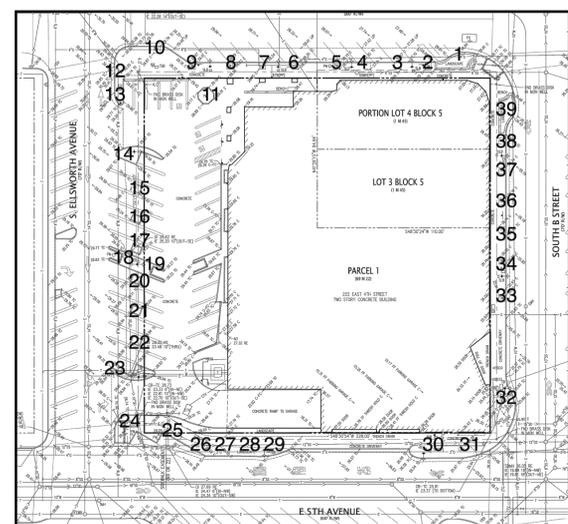
Appendix A: Tree Inventory Locations

There are no "Heritage Trees" as defined by the ordinance and all the trees are "Street Trees" except one olive. The trees are all located around the perimeter of the property on 4th, 5th, N. Ellsworth, and B streets. The inventory contains thirty-nine (39) trees comprised of four different species. There are five tulip poplar (*Liriodendron tulipifera*), eleven olives (*Olea europaea*), seventeen hackberry (*Celtis occidentalis*), and six Brisbane box (*Lophostemon confertus*). Most of the tree are in fair condition with thirteen good, one poor, two very poor, and the remaining twenty-three in fair shape and most have fair suitability for preservation except for the tulip poplars. All the trees are expected to be highly impacted and removed. The average L/U Value was calculated to be 4.079.
