**RE: West Santa Inez Condominiums**

I visited the site and have prepared multiple review letter in the last several months. My comments on the revised drawings are as follows:

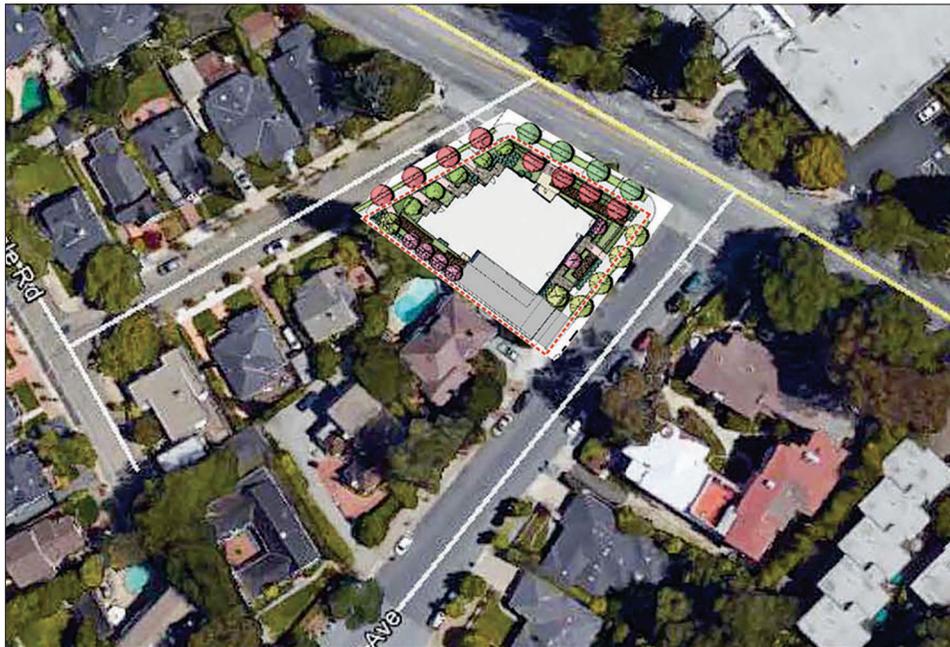
The proposed development has a relatively small footprint and would be surrounded by substantial landscaping - see landscape plan superimposed on the aerial photo below.

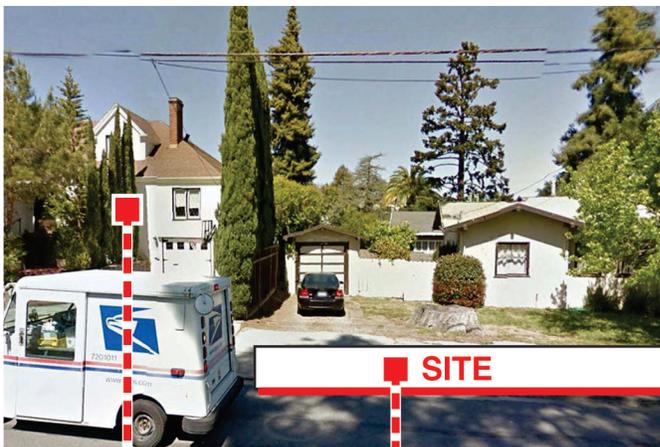
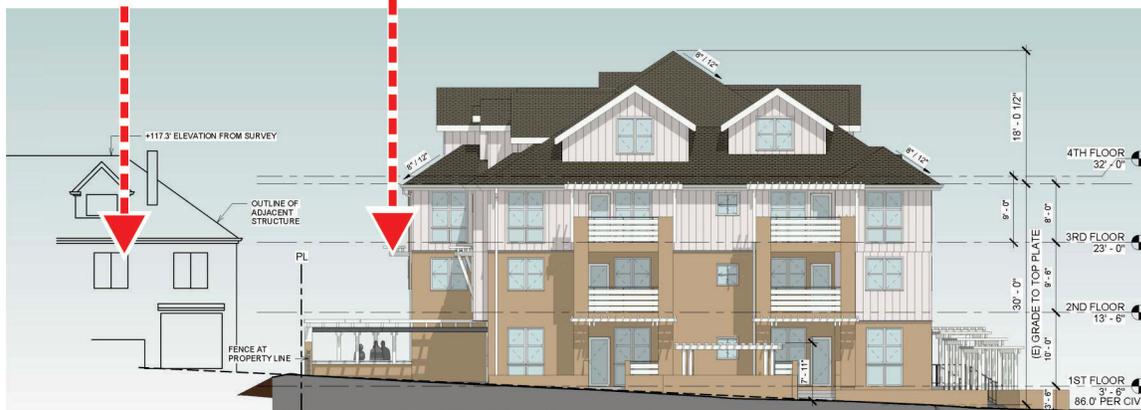
The project is well designed. Embedding the fourth floor within the roof form, as proposed, will reduce the visual mass of the structure to better relate to the nearby single family homes neighborhood.

While the proposed structure is larger than the homes in the adjacent neighborhood, the building mass has been articulated to relate to the smaller scale of the adjacent single family neighborhood with horizontal facade plane changes that break the building up into components that are similar to the module of the smaller homes. The proposed design also provides material changes that relate to nearby homes, and as well as individual home entries on West Inez Avenue and Engle Road. The only area that I was able to identify as problematical is the Engle Road elevation which has a two-story height differential between this project and the immediately adjacent single family home. However in my judgment, the large trees proposed at the west property line and the street trees will substantially mitigate this height differential.

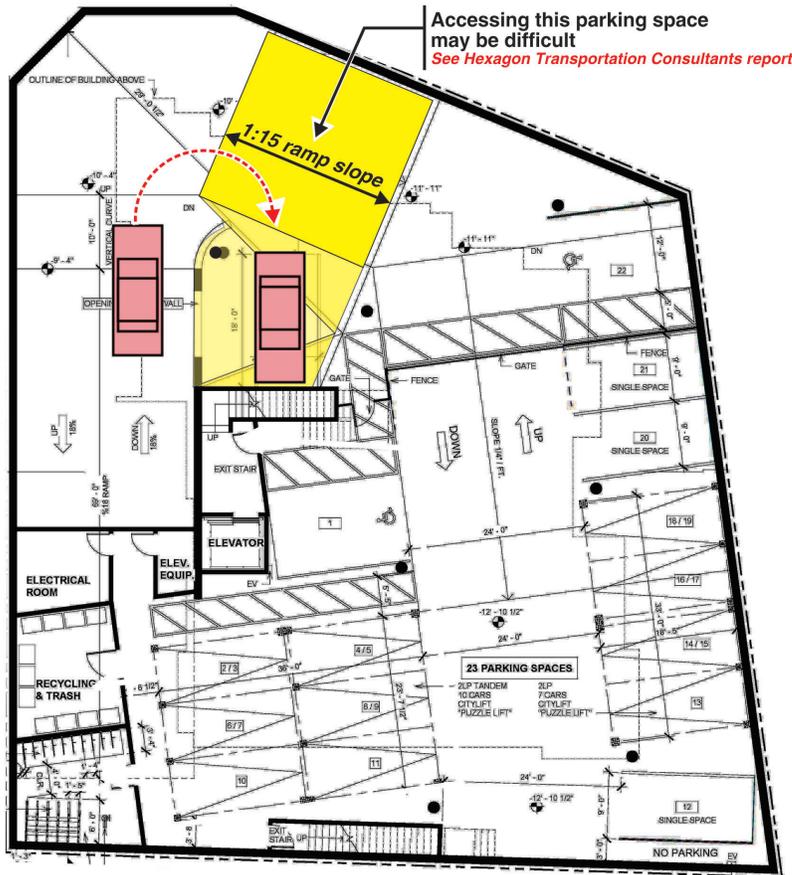
1. Accessing the parking at the turn located at the bottom of the garage access ramp may be difficult - see illustration below. This issue has also been highlighted in Hexagon Transportation Consultants report:

*The underground parking garage would be accessible from a single full access driveway on West Santa Inez Avenue in the southwest corner of the project site .... There are one standard parking stall and one handicapped stall shown outside the gate. The standard stall is shown to be accessed from a ramp with a slope of 1 in 15 (6.67%). While this conforms to the maximum allowable slope for parking spaces, it would involve making a multiple point turn to access the parking space.*

Substantial changes were made to the garage since my original review letter including an improved internal pedestrian link and the addition of a pony wall for visibility into the guest parking space.

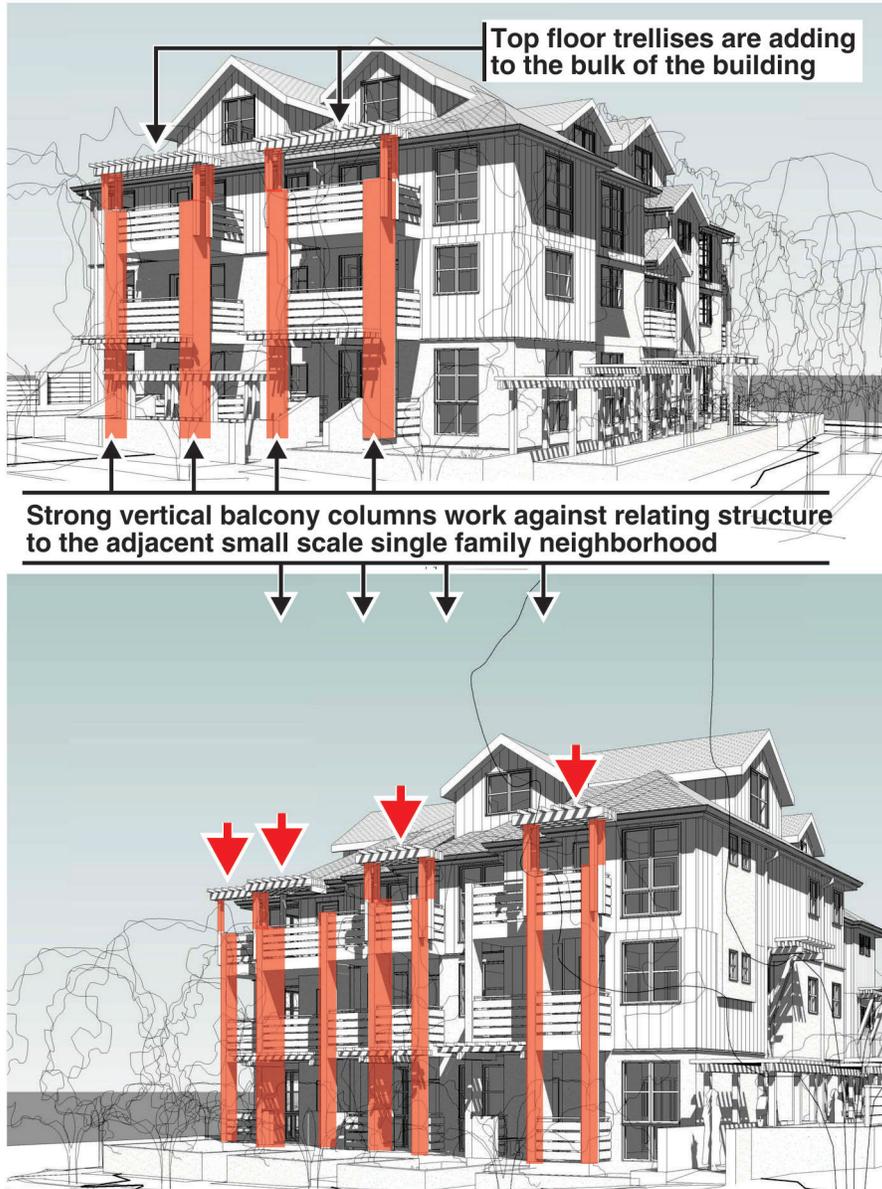
1. The strong vertical emphasis created by the stacked balconies with continuous vertical supports and top floor posts supporting the trellises makes the building appear taller, and more difficult to relate this larger structure to the adjacent small scale single family homes..
2. The top floor trellises are adding bulk to the building which is also working against creating a good relationship with the adjacent homes.

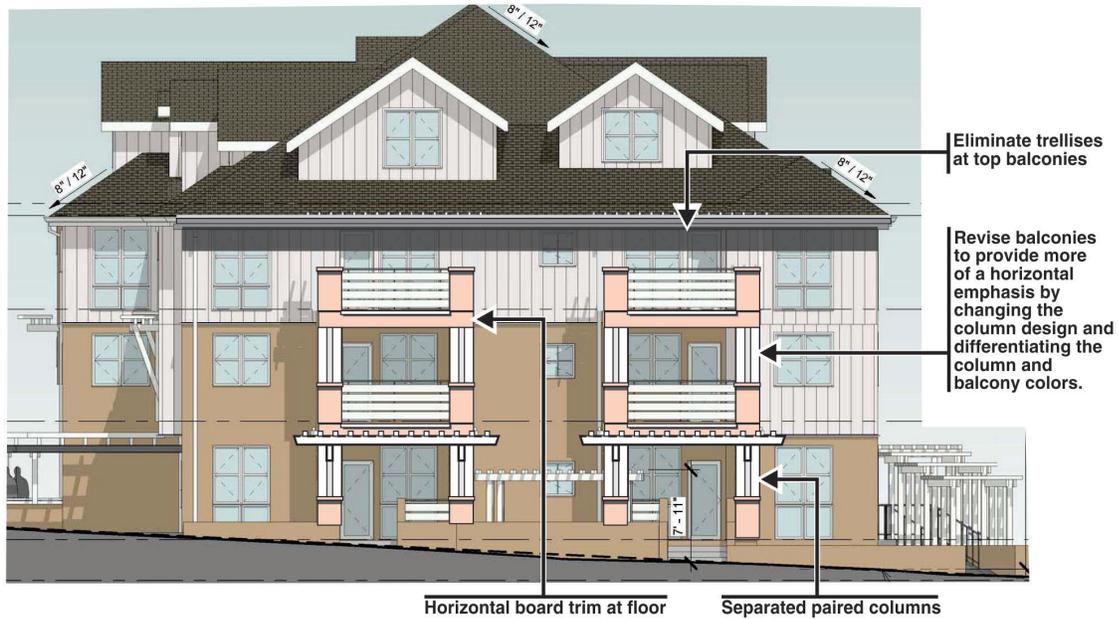
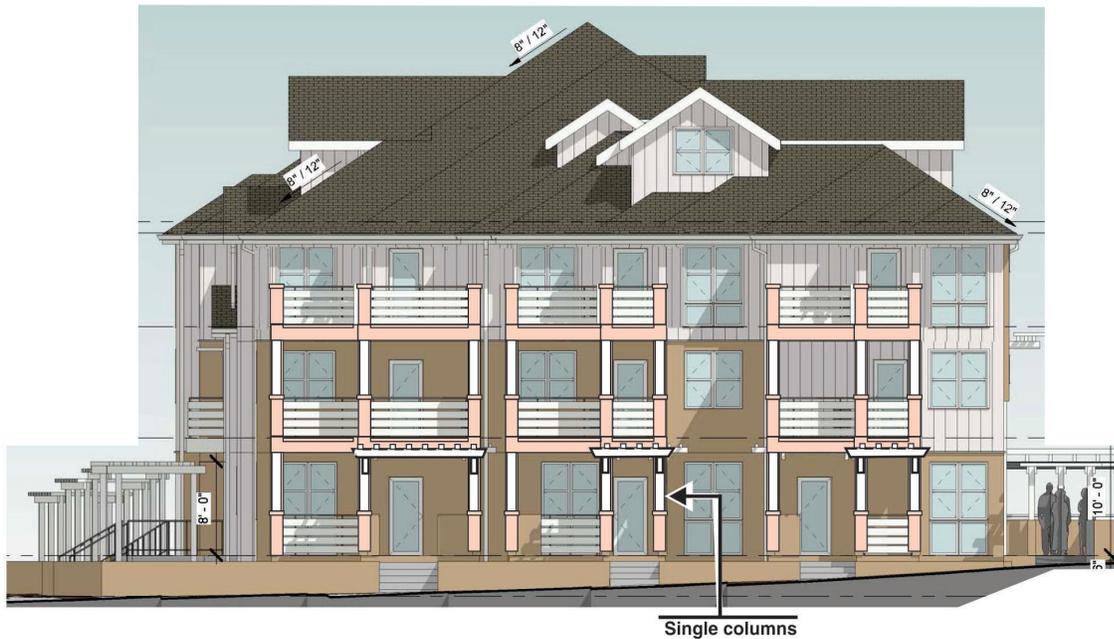
1. Revise the balconies to provide more of a horizontal emphasis - see illustrative recommendations below.
2. Remove all top floor trellises.
